CASE STUDY

OISD/CS/2025-26/P&E/09

Title: 220 KV cable fire incident in a RCC cable trench.
Location: Refinery
Loss/ Outcome: Complete damage of 4 nos. of 220 KV feeders (total 12 nos cables) in a span of 175 m

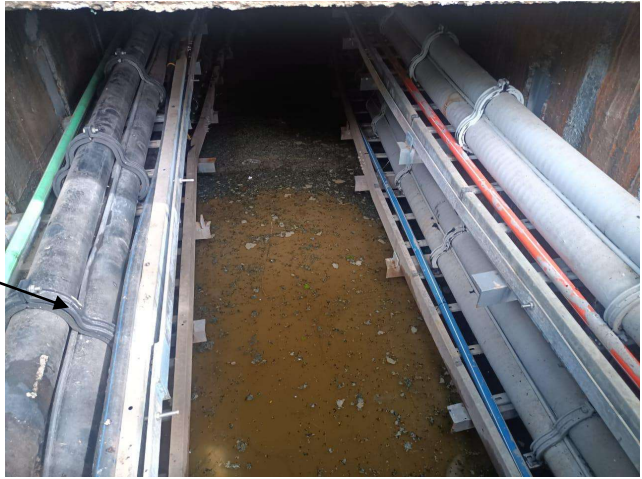
Configuration of cables in the trench – healthy portion

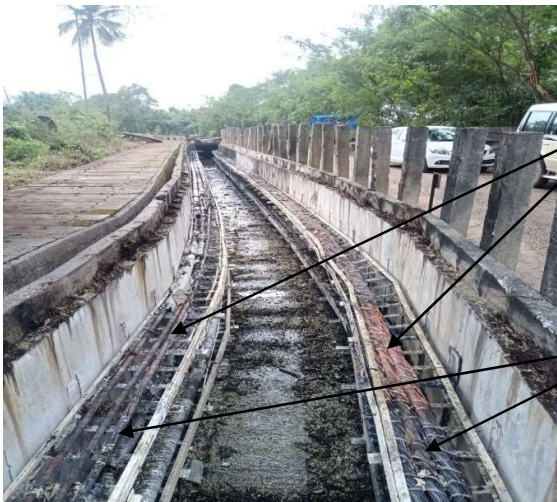
Extensive damage to all 12 power cables in a stretch of 175 m

Bare copper conductor with all outer covering viz XLPE insulation etc. melted away

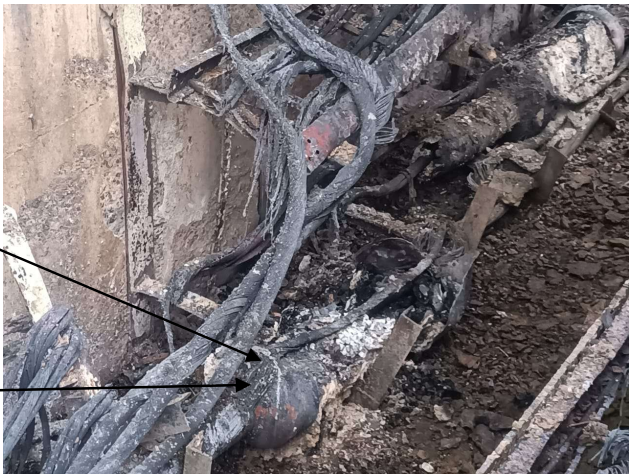
2. A fault was recorded for one of the feeder at State Electricity Board sub-station when it was charged after a maintenance job.
3. Extensive damage to the cable joint of R-phase of one of the cable, adjacent supports and chipping of concrete were observed near to the said joint. Apparently, during the charging, the failure of cable joint occurred accompanied with explosion.

Cable joint after explosion

Initiation point of the damage with extensive damage to cable trays, supports, adjacent concrete structure & melting away of copper conductor

The cable joint might have deteriorated due to poor workmanship during cable jointing or manufacturing issues and the charging of the cable resulted in the cable joint failure triggered by the switching surge. The cable joint explosion heat-initiated smouldering of insulations of other three feeders and resulted in failure of the other cables also.

3. EHV Cable joints inside a cable trench should be protected against fire/explosions by suitable means like fire- and explosion-proof partitions, joint protection boxes, fire- and explosion-proof blankets, covering with sand etc.

6. Industry to carry out the root cause analysis for cable joint failure along with the cable OEM's. Any recommendations thereof shall be implemented in a time bound manner.
