CASE STUDY

OISD/CS/2025-26/E&P/19

Title : Fatal Accident during dismantling of Drilling Rig

Location : Onshore

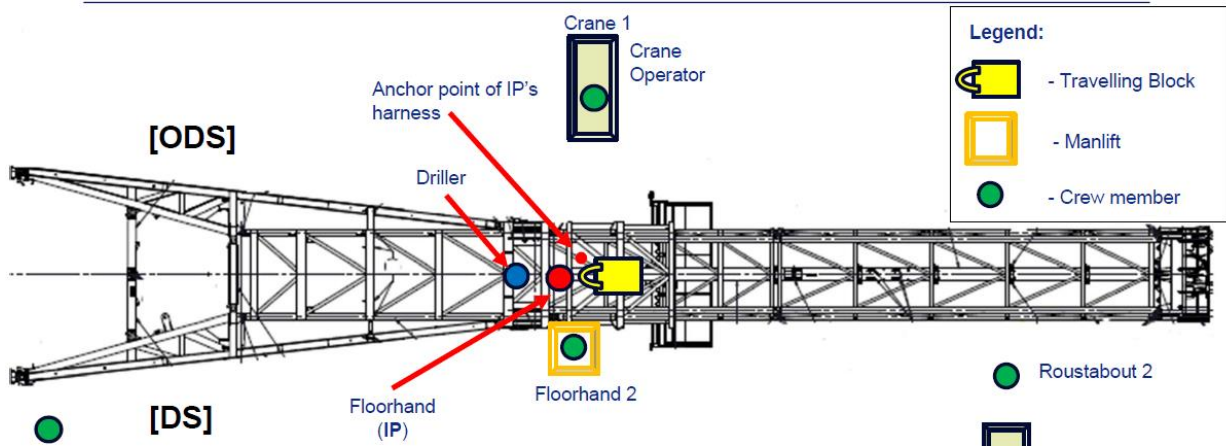
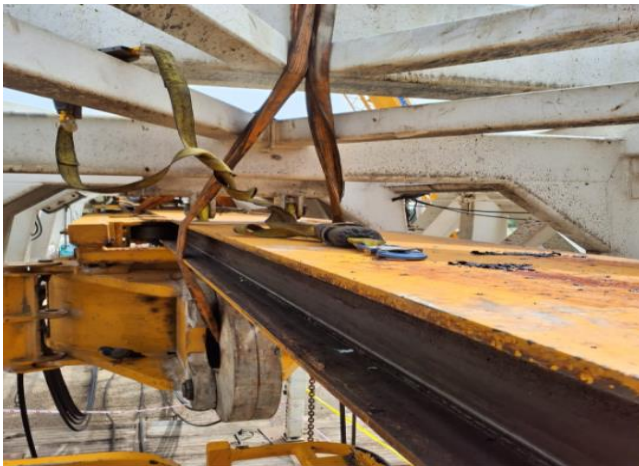
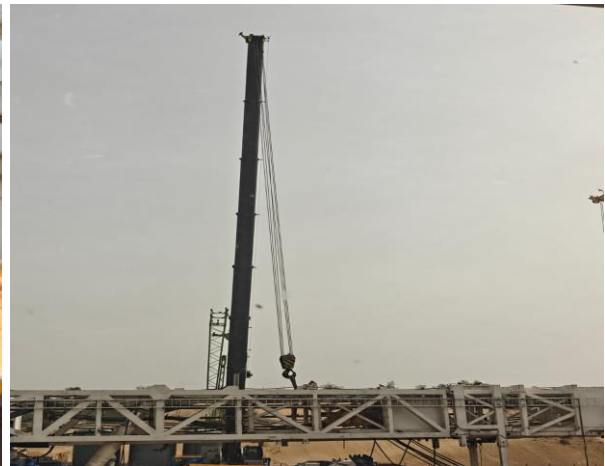
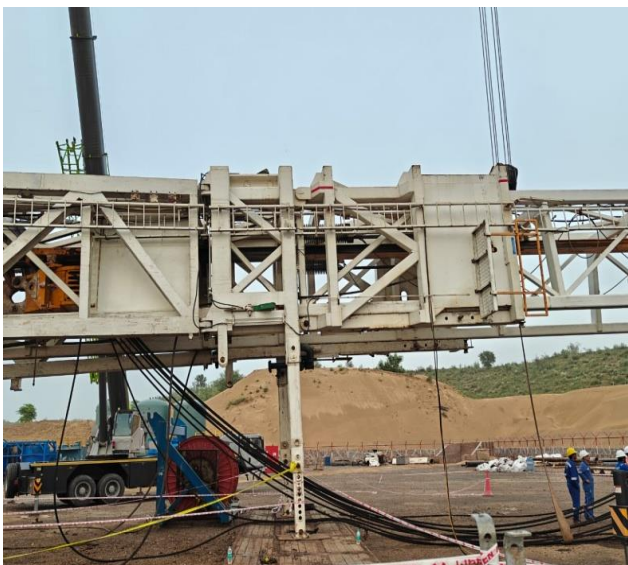
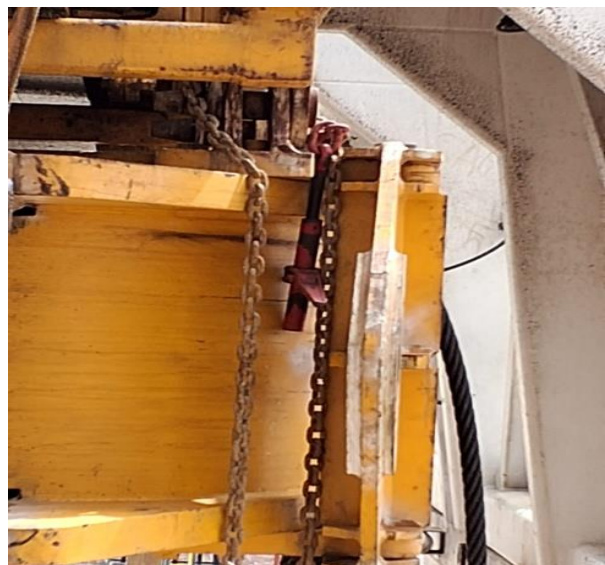
Event Description (Visual – Layout)

The crane operator, acting on signals from the Driller who was relaying the IP's instructions, began tensioning the sling. When the chain securing the travelling block appeared slightly slack, the IP started loosening it using the ratchet boomer. Suddenly, the travelling block shifted approximately 1.5 meters toward the crown block, pulling the IP along with it. The IP struck the TDS (Top Drive System) guide rails and nearby rig structures, sustaining severe injuries. He was taken to a nearby hospital and later referred to city hospital, where he was declared dead on arrival.

- 4) Safety Harness of IP was anchored at incorrect location and harness lanyard was in the line of movement of the travelling block sling. Correct anchoring position for lanyard was not discussed in JSA.

- 7) The boomer's hook portion detached from one side during loosening, possibly due to excessive tension or pre-existing damage. Part of the failed ratchet boomer remained stuck with the travelling block. No periodic inspection report was available.

- 4) A pre-task harness inspection checklist should be incorporated requiring verification that the lanyard anchor point allows movement without risk of entanglement or getting trapped in the path of movement of heavy objects.

- 6) A dedicated signalman stationed with direct line-of-sight to worker and crane operator should be deputed for the job.
- 7) All equipment including ratchet boomer should be inspected before use. Periodic inspection of lifting and associated devices (including slings and ratchet boomer) should be practiced.
