CASE STUDY

OISD/CS/2025-26/E&P/21

Title: Gas blowout incident at Workover Rig

Location: Onshore- Workover Rig

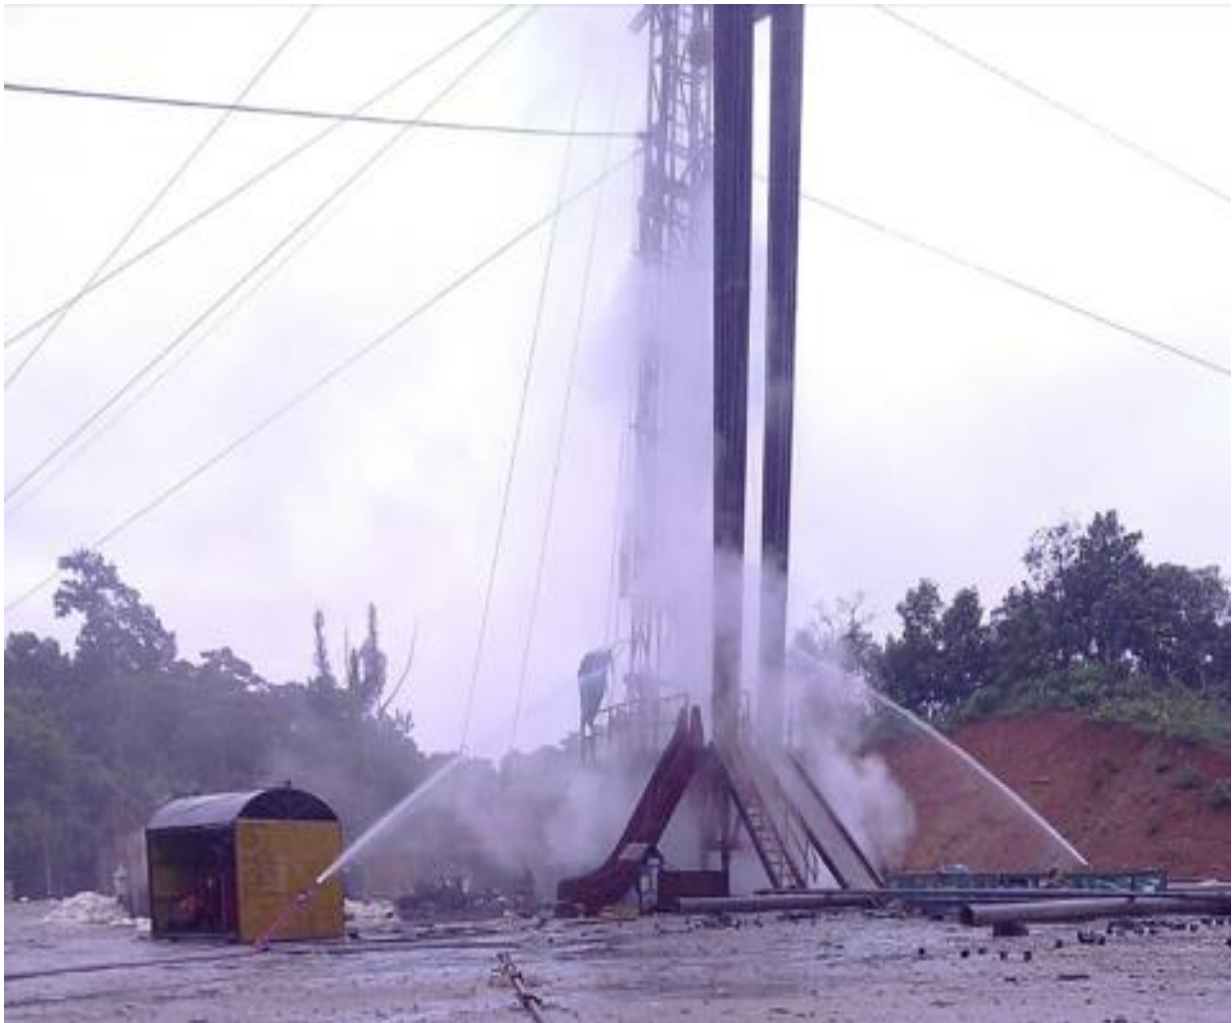
SITE PICTURES:

A gas blowout incident occurred at a well immediately after perforation of the target interval during a conventional perforation operation at a workover rig. Uncontrolled gas flow was observed, and emergency response procedures were activated. No injuries or fire were reported. An attempt to shut in the well using the production BOP (blind ram) while the wireline string was still inside the hole was unsuccessful.

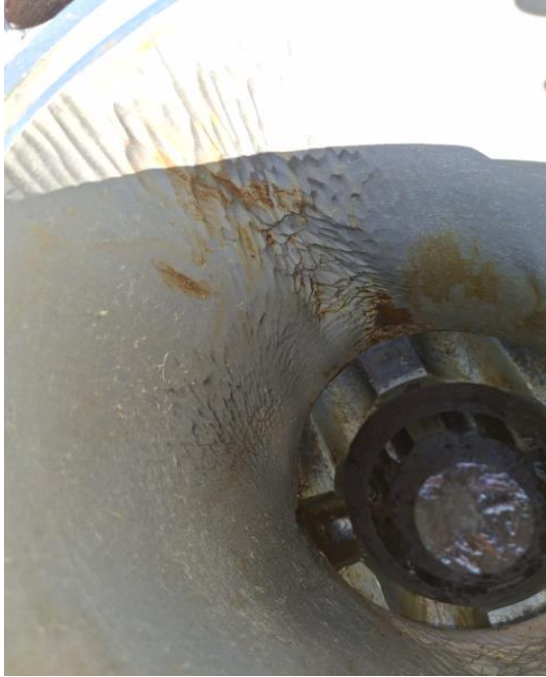
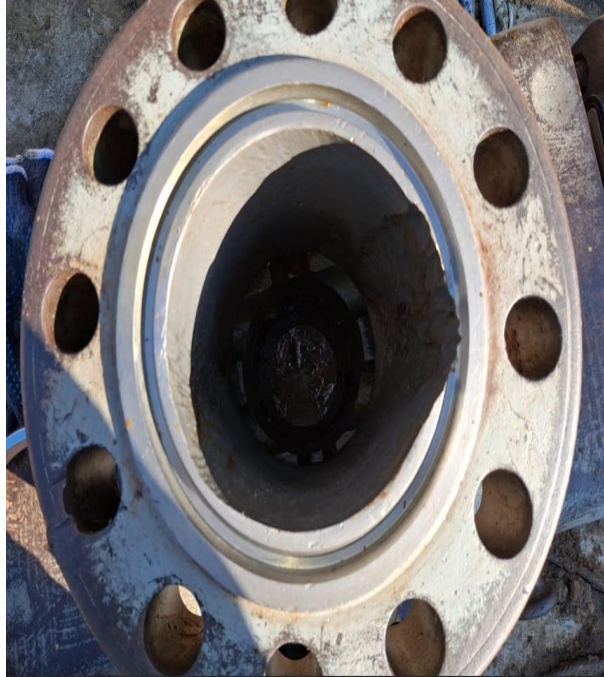
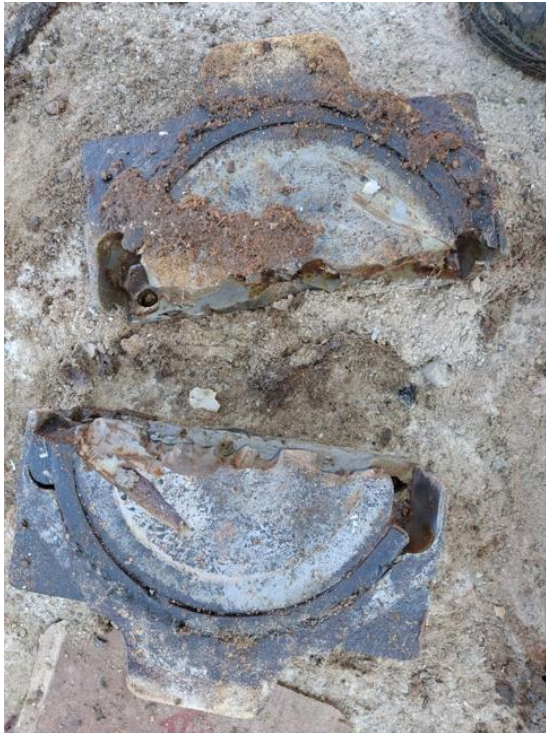
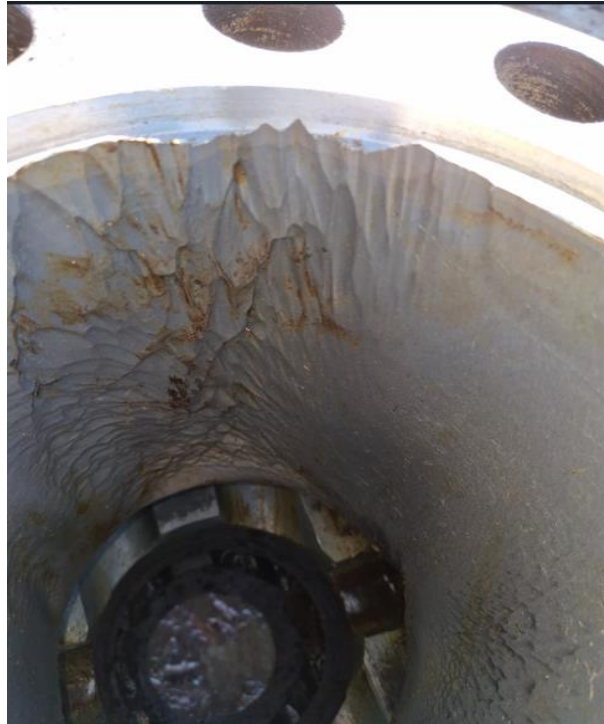
- e. BOP stack had no shear ram, violating Clause 6.3.1, making it impossible to shear wireline and seal the well during gas flow. Blind ram closure could not seal the well with the wireline inside the well.

Damaged BOP

- b. Review requirement of wireline Pressure Control Equipment (PCE)
 - c. Selection of BOP stack.
 - d. Carrying out conventional perforations.
 - e. Review perforation SOP to include actions in case of well kick.
