CASE STUDY

OISD/CS/2026-27/E&P/02

Title: Fall of travelling block.
Location: Onshore workover rig.
Loss/ Outcome: Financial loss.

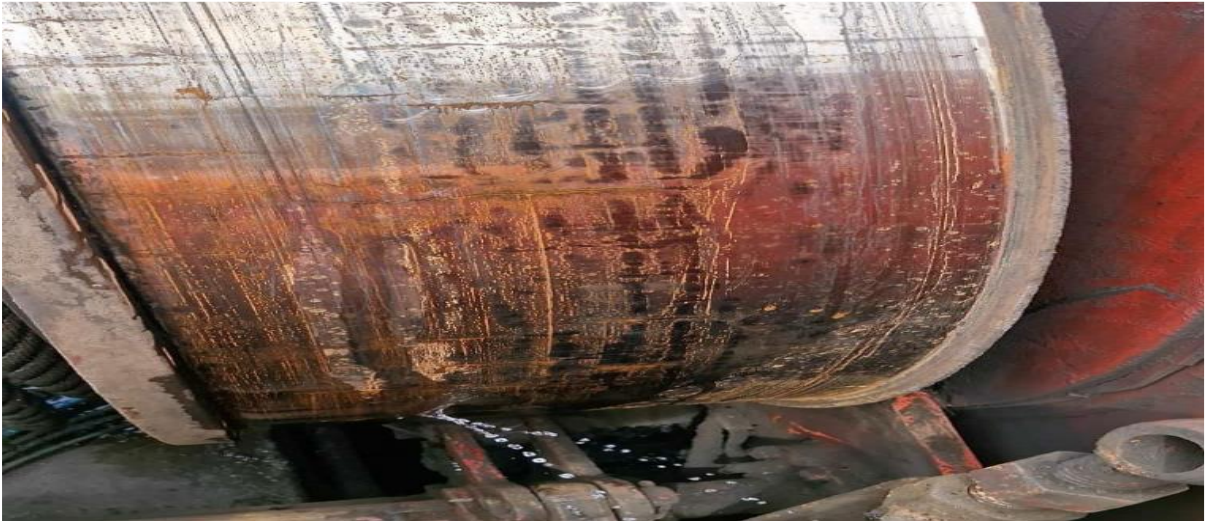
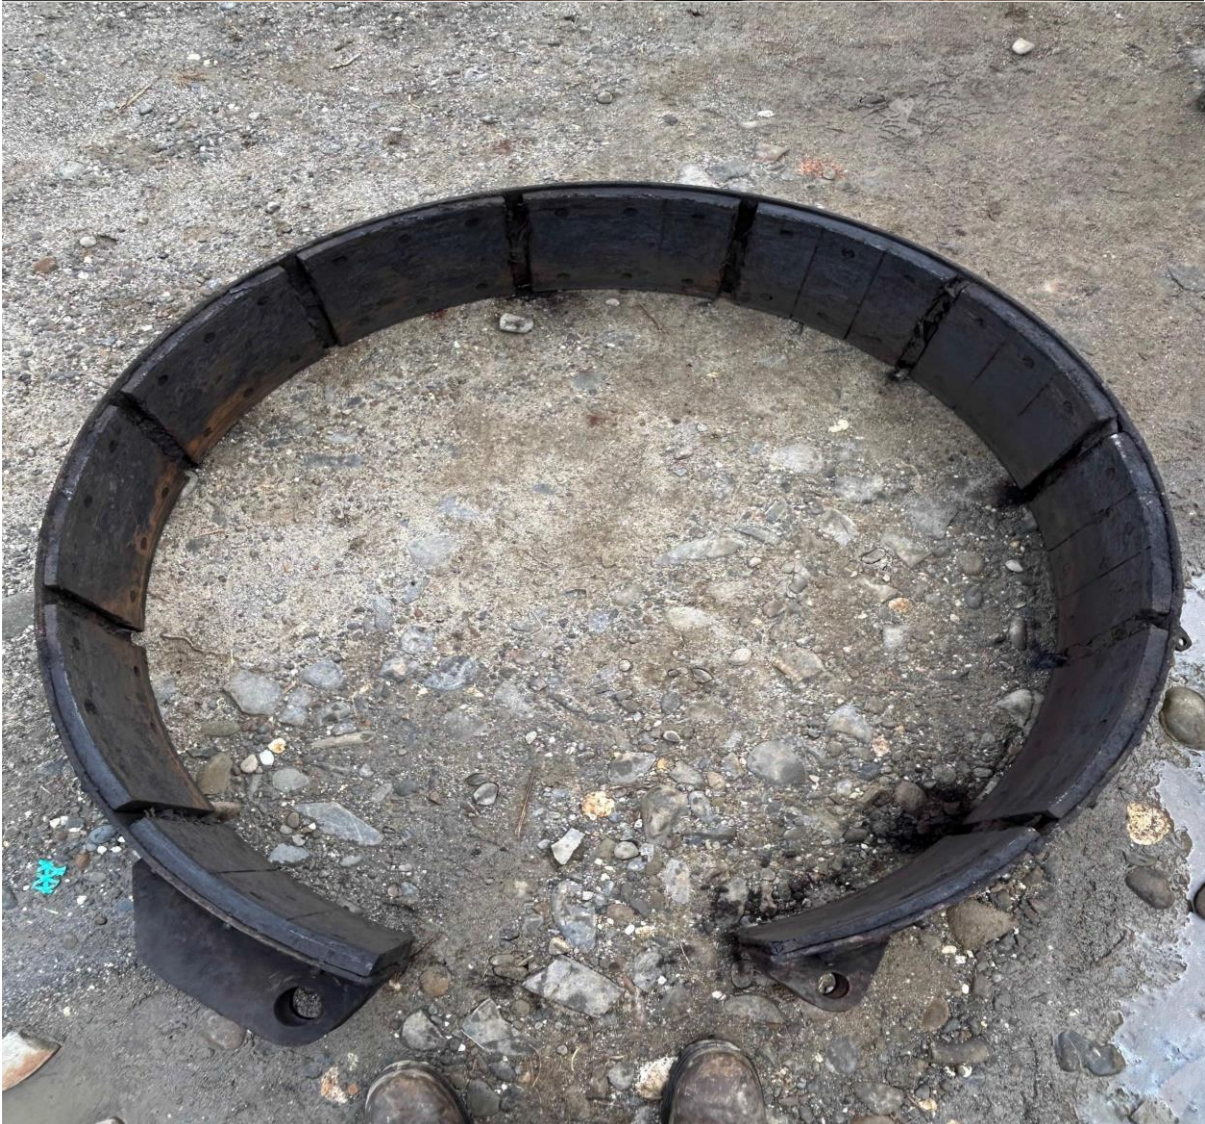
Pictures of Brake drum and shoe after the incident

- Multiple horizontal cracks were observed at several locations on the left-hand brake drum. These cracks are likely to have developed due to leakage of cooling water, which came in contact with the braking surface, thereby significantly reducing braking efficiency.

- The brake shoes were observed to be unevenly worn out and burnt. As per the draw-works logbook entry, all brake shoes were replaced recently. The reason for replacement of brake shoes was not mentioned in the logbook. The details of the manufacturer of the replaced brake shoes could not be verified from the available documentation, indicating a possibility that non-OEM / non-standard brake shoes may

have been used. The presence of cracks on the draw-works brake drum was not reported or recorded during this maintenance activity.

- Poor and ineffective maintenance of rig equipment.
- Uneven worn-out brake shoes and horizontal cracks in the left-hand brake drum might have resulted in cooling water of brake drum coming in contact with braking surface and resulting poor braking action. This resulted in loss of desired mechanical property required for brake to function properly.

- The gap in competence level of rig personnel should be identified and addressed as per OISD-STD-176.
- The preventive maintenance schedule should be strictly adhered to. Logbooks should be maintained inclusive of major repairs and replacement of equipment parts. Traceability for the replacement of spares consumed should be maintained with quality considerations.
- Root cause analysis of failures of critical components shall be carried out, and the resulting recommendations shall be effectively implemented.
- The rig crew should be trained and encouraged to identify and report unsafe acts and unsafe conditions. Appropriate corrective action should be ensured as per OISD-GDN-206.
