A CASE STUDY

OISD/CS/2026-27/E&P/03

Title: A minor fire incident at well site.

Location: On-shore Location.

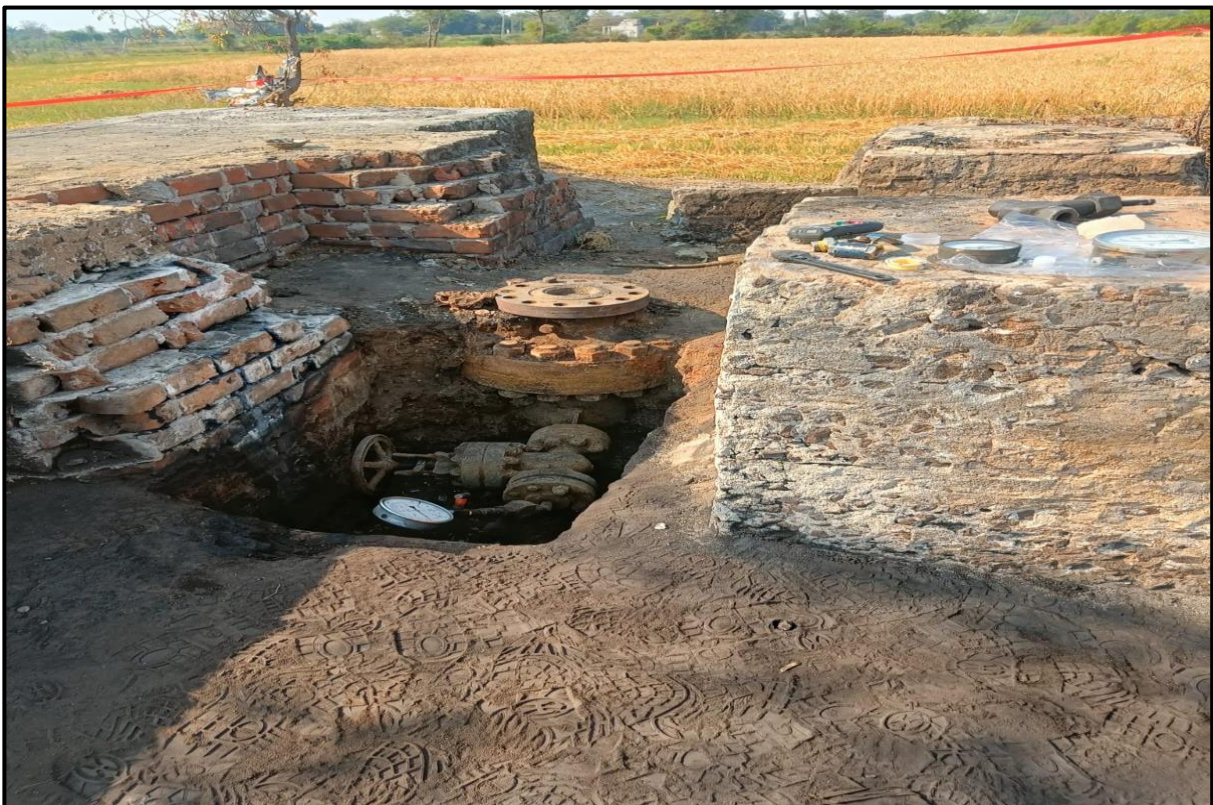
Picture-3

Well site and annulus
