CASE STUDY

OISD/CS/2026-27/PL/04

Title: Incident of piercing & leakage from LPG pipeline, while drilling for soil investigation survey for other pipeline in common ROU.

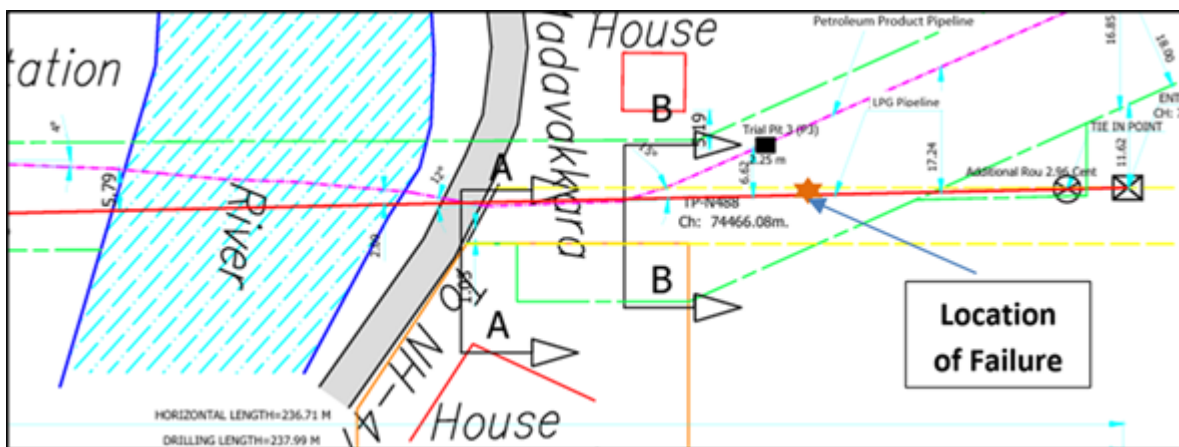
River Crossing

- The location of the incident was downstream of a River crossing at petroleum product pipeline chainage 58.7 Km (LPG pipeline chainage 74.4). Petroleum product pipeline

was initially laid through open cut method across the river whereas LPG pipeline was laid through the HDD method. A road is also available in parallel to the river on the downstream side and the same is considered as a part of crossing along with river. The ROU width at the upstream side of the river was 15m whereas at downstream side it is 18 m (after the road). The section drawing of the location with respective pipeline crossing is as under:

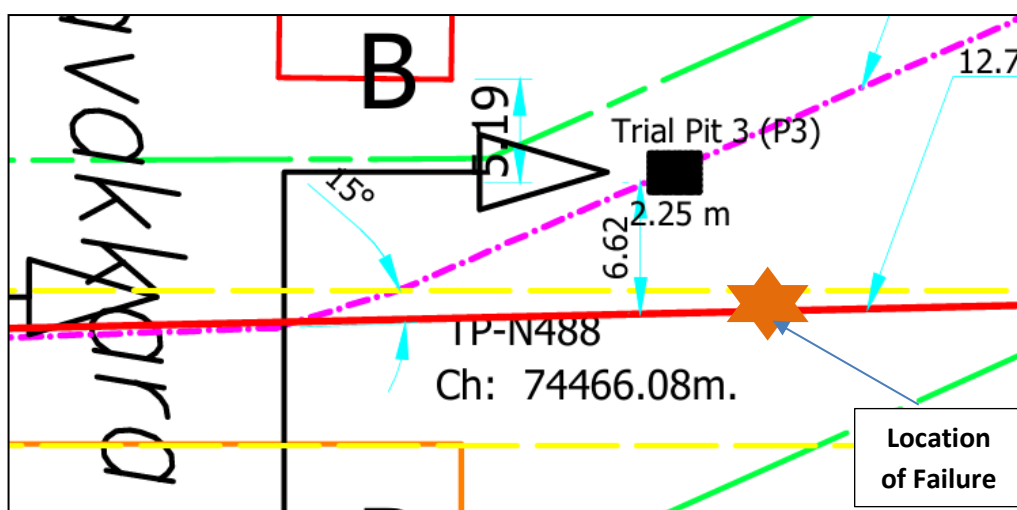
Location of failure

On 18th March 2026 at around 0915 Hrs., an LPG leakage incident was reported in ROU of an LPG pipeline of a company (say M/s XYZ). It was informed that the incident had occurred during the soil investigation activities being carried out at said site by other company (say M/s ABC) in common ROU (LPG pipeline is laid in common ROU with liquid petroleum product pipeline of other company M/s ABC). The boring/drilling machine used for boring of soil had punctured and damaged LPG Pipeline.

1. The "Issue for Approval" drawing for HDD Profile of river crossing of LPG pipeline was shared with the officials of petroleum product pipelines on 24.05.2021 during the construction stage and it is understood, that same was agreed by them with respect to the inter-distances, laying methodology and crossing orientation etc. The As-built drawing of the river could not be traced. However, it is to be noted that the available crossing drawing (issue for approval) was neither referred to by officials of petroleum product pipeline nor by the officials of the LPG pipeline before carrying out the soil investigation work.

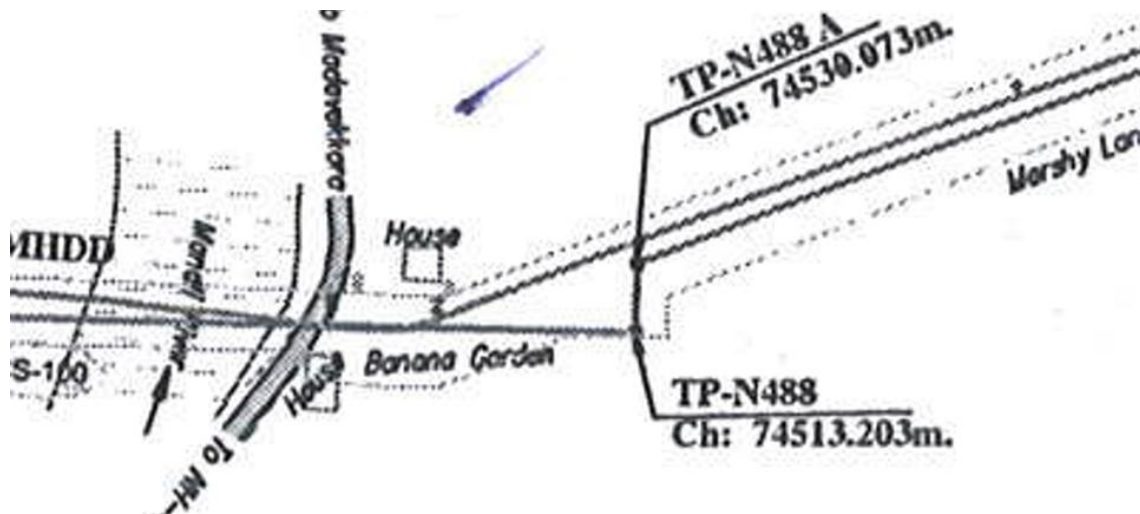
Alignment of pipelines with location of Turning points markers

3. As per alignment sheet, it is observed that after the HDD crossing, LPG pipeline is taking two turns to align with the ROU/ mainline of petroleum product pipeline. However, in the field/ROU, none of Turning Point markers were available (TP -N488 & TP-N488A as per alignment sheet).

5. Turning/ Direction markers are to be installed indicating the direction of turning for all the pipelines in line with the OISD-STD-141/214. One direction marker shall be installed at each turning point and in addition two more direction markers shall be installed along the pipeline alignment, one on both side of turning point at a distance of 200 meters from the turning point. Lat, long data for such markers shall be recorded and preserved. Further, regular monitoring of the requisite pipeline markers in the ROU to be carried out.
