## CASE STUDY

OISD/CS/2026-27/E&P/06

**Title:** HVAC fire in machinery deck.

**Location:** Offshore drilling rig.

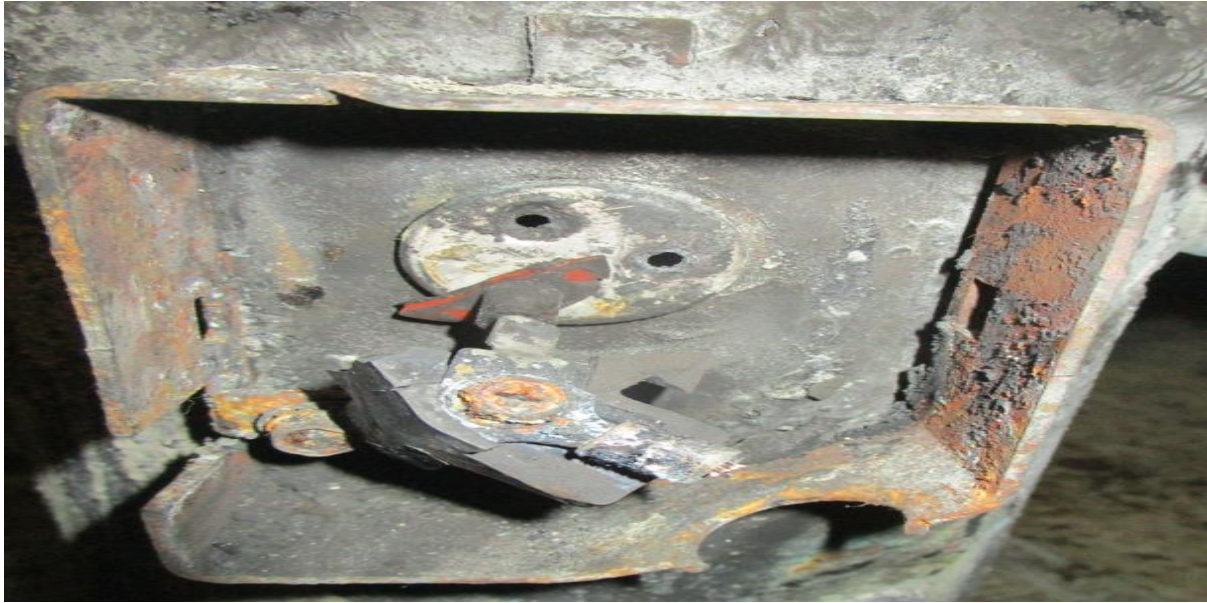
- Two out of the three live terminals of the HVAC compressor were found blown off.
- Parameters like temperature and oil pressures were not monitored, except suction and discharge pressures.
- There were no written OEM guidelines available for what to cover during monthly inspection of HVAC unit.
- Records for arc Chute test of terminal were not available. No record was available for calibration of Low-Pressure and High-pressure switch installed on the compressor.

The immediate cause of the incident is dislodgement/ snapping of terminals at the compressor entry points. This led to the spraying of compressor oil onto exposed live terminals, resulting in the explosion leading to fire.

- Short circuit to the ground within the compressor
- High resistance at the electrical terminal due to loose connections.

**Figure 1: Terminal of the HVAC compressor after the incident**

- Management should strengthen preventive maintenance and inspection based on OEM recommendations for early detection of comprehensive defects and hazards of all HVAC units. A detailed preventive maintenance checklist should be developed and followed.

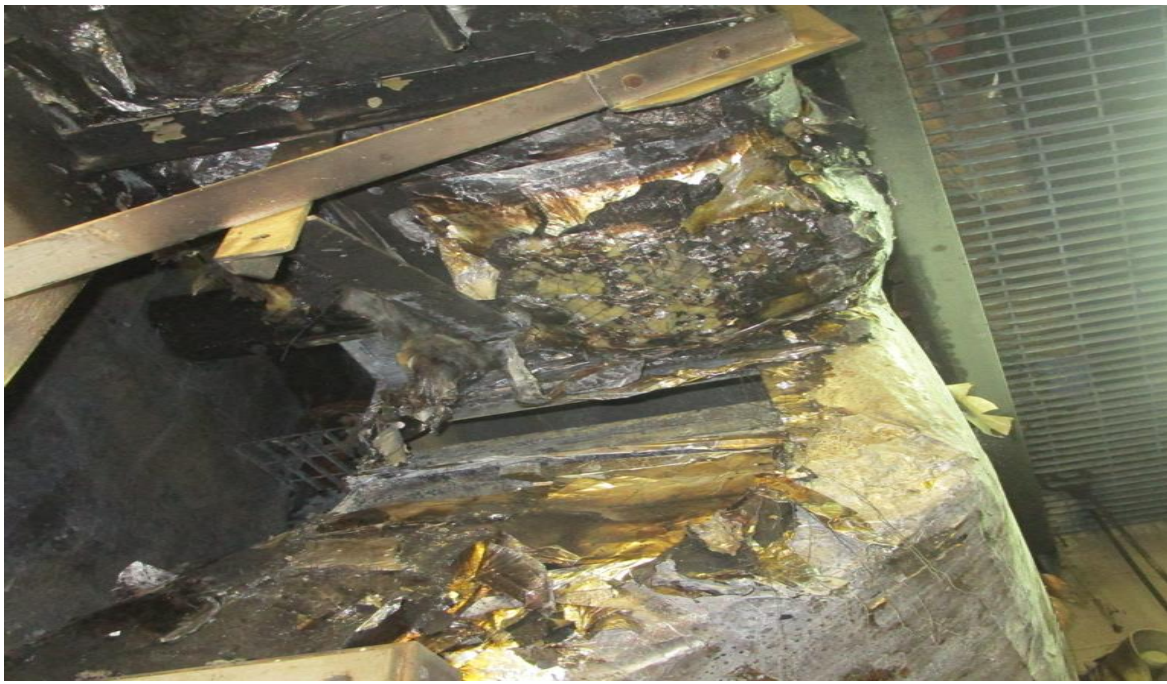
- The duct insulation near the HVAC unit was found burnt after the incident indicating the presence of combustible material in the insulation that ignited after the explosion. Also, there was a platform built above the affected room which was being utilized as a storage area for combustible materials like compressor separator filters, air filters, and other mechanical spares etc.
- There was no provision of fixed fire suppression system in the workshop area as per original rig firefighting arrangement.
- There was no structured training module for electrical crew members which would equip them with the knowledge and skills necessary for effective maintenance and troubleshooting of the AHU and compressor systems.

**Figure 2: Damage to duct insulation of HVAC**

- It is recommended that the insulation provided around the HVAC ducts should be of non-combustible type and free of any combustible material. Periodic inspection of duct insulation and its surrounding area should be ensured to maintain its integrity and fire safety performance.
