CASE STUDY

OISD/CS/2026-27/P&E/08

Title: Fire Incident in Crude and Vacuum Distillation Unit (CDU/VDU)

Location: Refinery

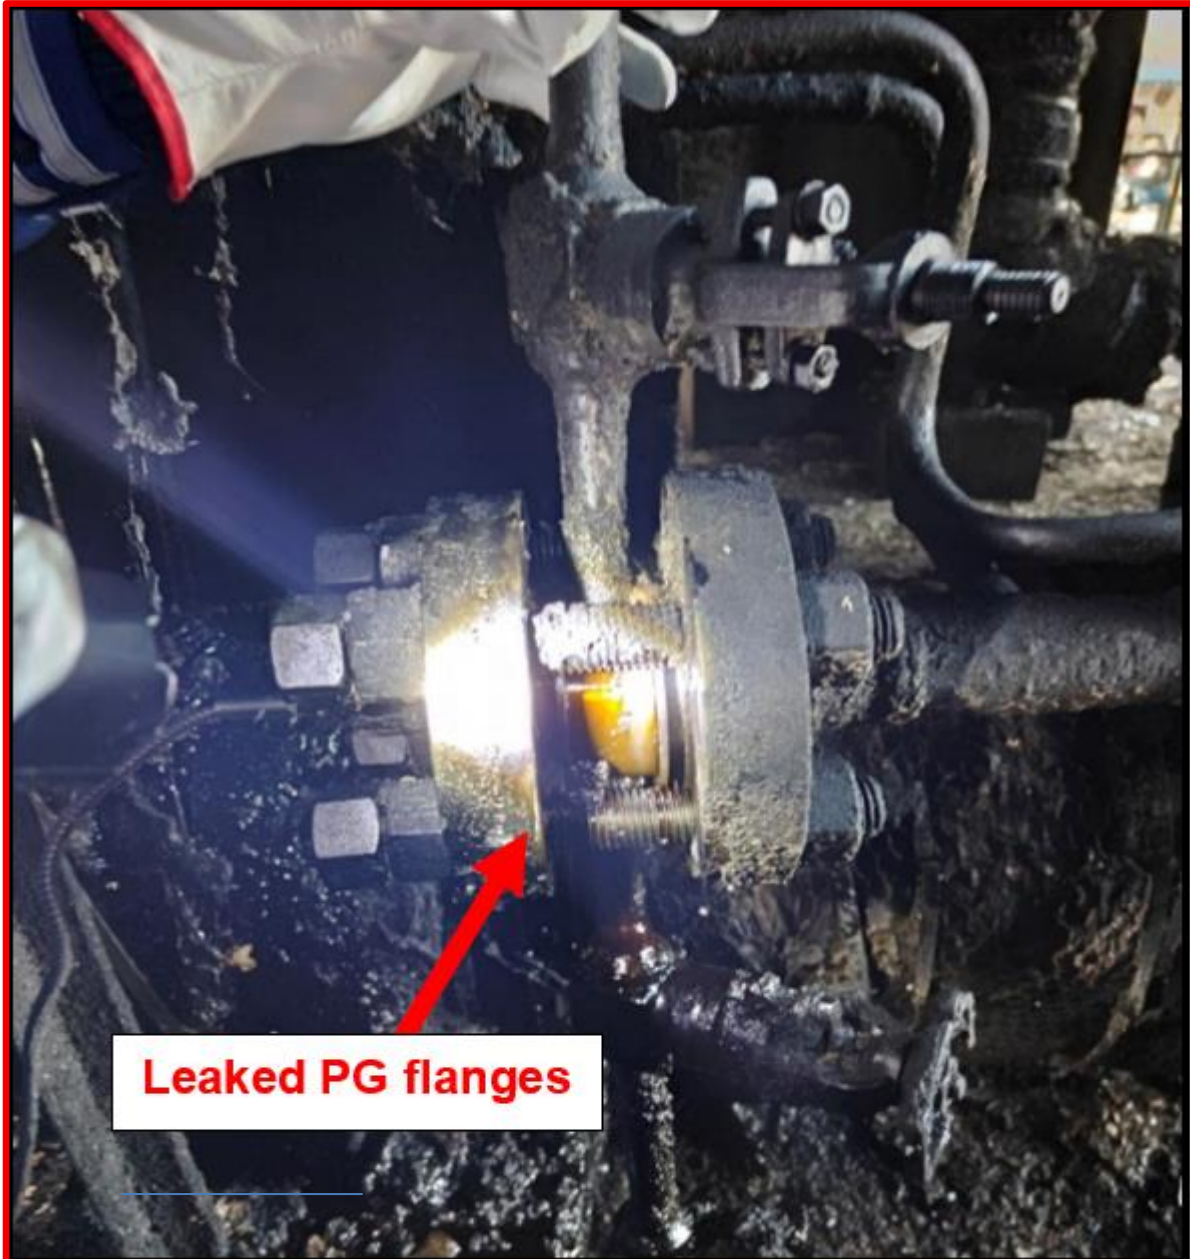
1. Dripping of VR (predominantly reduced crude oil - RCO) stream was observed from the flanges of the diaphragm-type pressure gauge installed on the vacuum residue (VR) shell-side inlet line of the crude versus vacuum residue exchanger (located on ground level). The flushing ring assembly of the pressure gauge was also found loose.

2. The spiral wound gasket of the assembly was damaged and positioned off-center, indicating improper box-up and misalignment. Accordingly, the sealing integrity of the assembly seemed to be compromised. The compromised pressure gauge assembly was concluded as the source of the initial leakage of hot vacuum residue (predominantly reduced crude oil - RCO) at auto-ignition temperature.

1. Improper box-up and misalignment of the flushing ring assembly of the diaphragm-type pressure gauge installed on the vacuum residue (VR) shell-side inlet line caused damage and improper seating of the spiral wound gasket, resulting in leakage of hot vacuum residue (predominantly RCO).
2. Causes for Escalation
 - Alarm flooding and muted alarm audio resulted in non-cognizance of the high-high pressure alarm prior to flushing oil (FLO) line rupture. Hence, the shutdown and isolation of the flushing oil line was delayed.

Leaked PG flanges

Initial Leak Source – Pressure Gauge Tapping Assembly of VR line

- a. Integrity of gland packing assemblies, pressure gauge (PG) connections and temperature tapping (TT) connections should be ensured through proper inspection, assembly verification, maintenance and certification practices under the Gasket Stud Functional Committee (GSFC) system prior to startup.

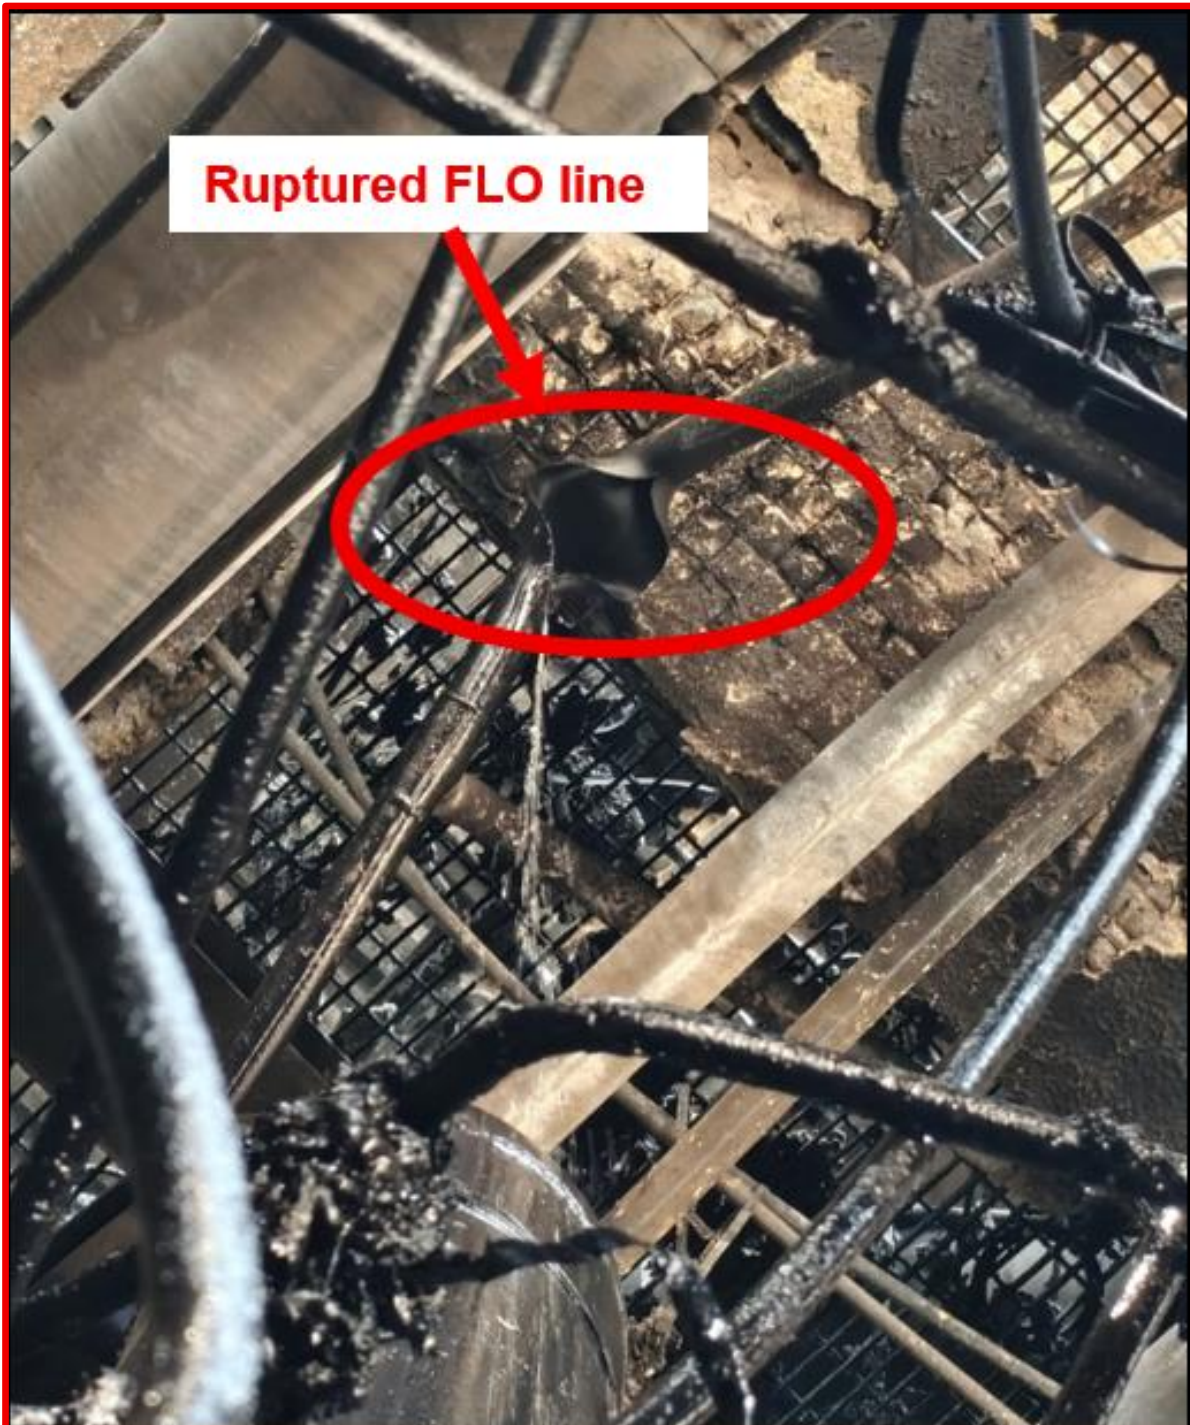
3. A fish-mouth rupture (around 6") was observed in the 2-inch flushing oil (FLO) line located just below the first platform of the technical structure (TS), approximately 5–6 meters above the fire initiation area. The line was provided for flushing the tube side of the CRUDE/HVGO CR EXCHANGER located on the first platform of the TS.

4. The pressure indicator of the FLO line showed a rise from 23.4 kg/cm² to 68 kg/cm² between the citing of smoke and sudden intensification of fire, approximately 4 minutes after the initial outbreak, as per the CCTV footage. Then the FLO pressure dropped down to 2.3 kg/cm². This implied that the FLO line got pressurized due to heating up in a blocked condition in the flame emanating from the ground floor. It then ruptured, adding FLO into the fire.

Ruptured FLO Line – Secondary Hydrocarbon Source Escalating the Fire

- b. Hydrocarbon lines susceptible to blocked-in thermal overpressure conditions, including fire case, should be reviewed and the feasibility of providing suitable overpressure protection devices such as Pressure Safety Valves (PSV) / Thermal Safety Valves (TSV), with safe relief routing arrangements, should be considered.

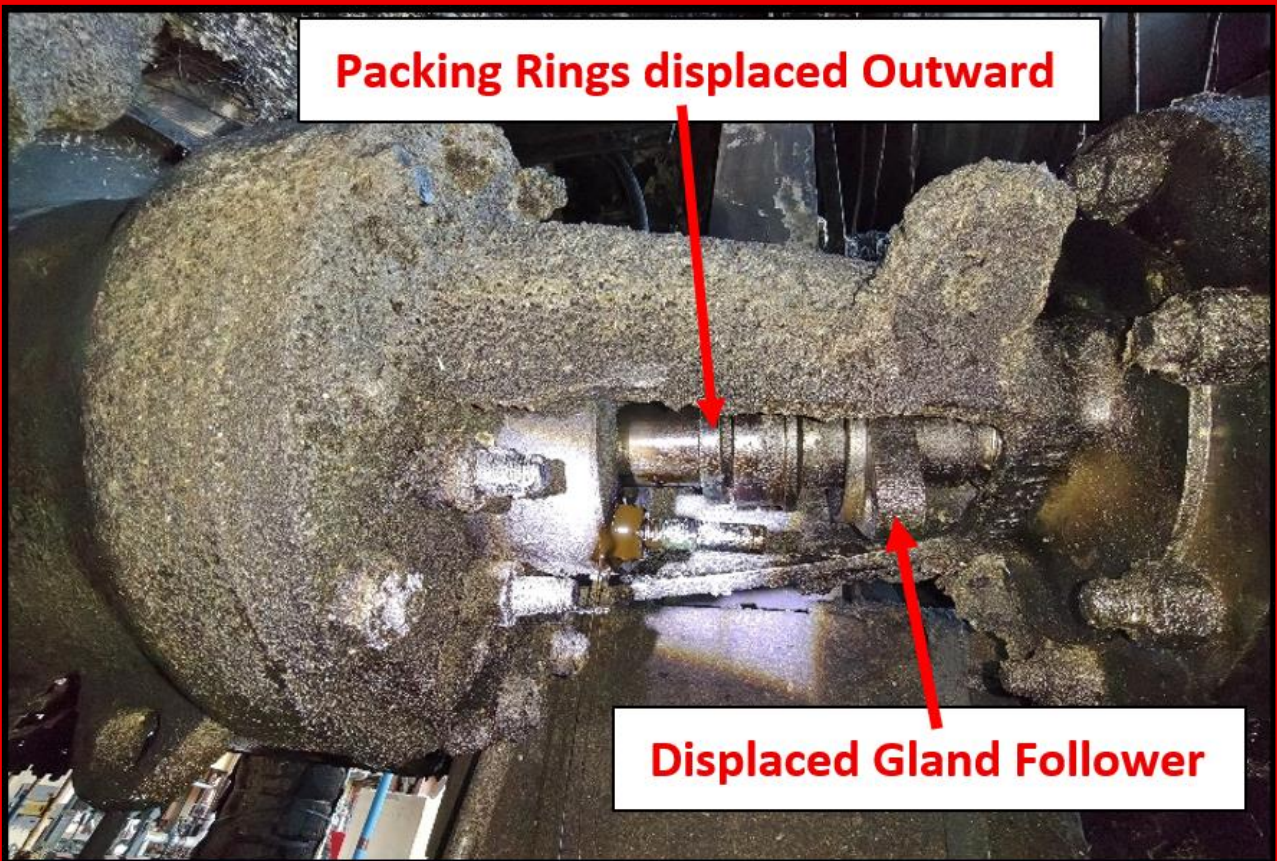
7. Dripping and minor leakage of VR stream (predominantly RCO) was also noticed from the gland area of the vacuum residue (VR) inlet gate valve of the same crude versus vacuum residue exchanger. Displacement of the gland packing and gland follower assembly of the valve was identified. The eye-bolt nuts were found disengaged and outward thread deformation was noticed on the gland flange studs, indicating additional leakage through the gland opening during the incident.

8. The vacuum residue (VR) inlet isolation gate valve was found maintained in a partially open condition without backseat engagement, resulting in continuous process pressure acting on the gland packing arrangement and making the gland more susceptible to leakage.

Failed Valve Gland Assembly – Additional VR Leak Source Sustaining the Fire
