केस स्टडी / CASE STUDY

OISD/CS/2025-26/MOPOL/20

Title: Fire Incident at Above-Ground Ethanol Storage Tank During Receipt Operations

Location: POL Installation

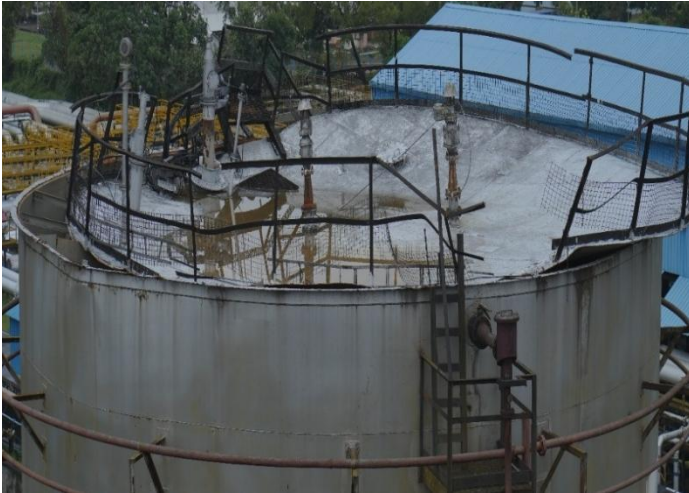
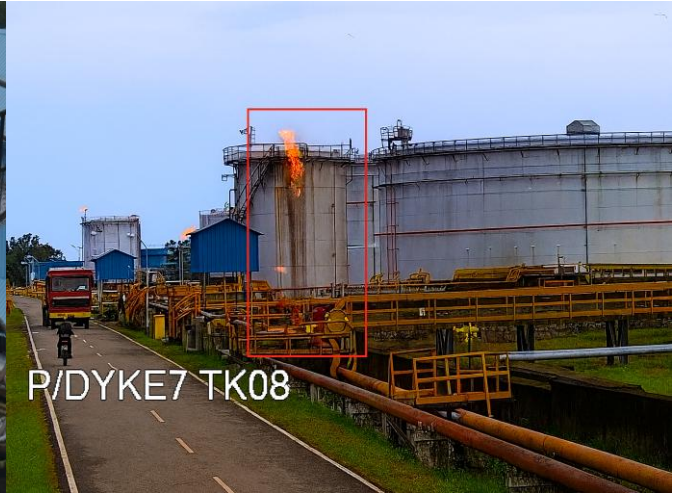
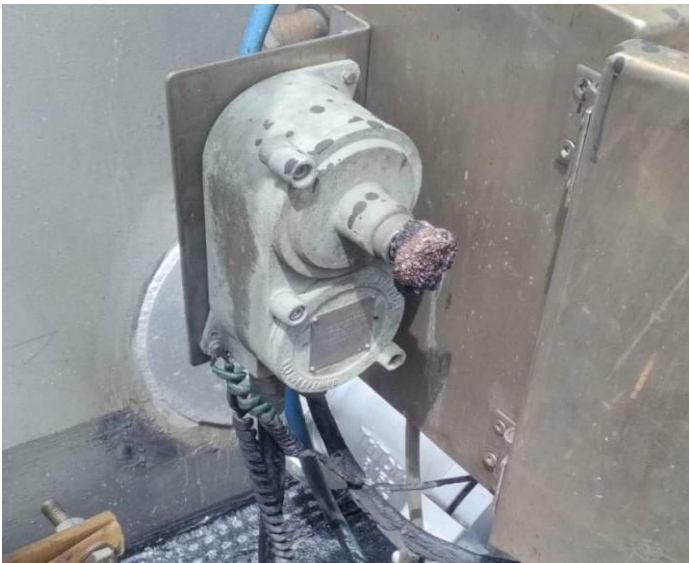
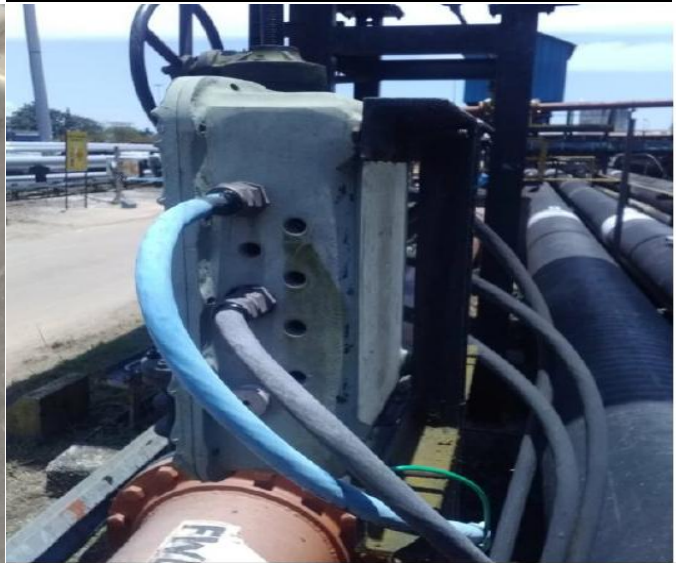
During an unloading operation of ethanol from tank trucks to AG fixed cone roof tank, a loud noise was heard followed by a fire. As a result of the accident, the tank was momentarily lifted off its sand foundation before settling back down, and the roof was horizontally displaced by approximately one meter. Multiple jet fires erupted from the 1-inch thermal expansion line connected to tank, while ethanol dripped onto the ground from the ruptured pipeline, which caused the fire to spread to the tank inlet ROSOV and its associated cables. The combined spill and jet fires continued for approximately three minutes.

- Maintenance and inspection records for the expansion line were not available.
- The explosion occurred due to abnormal vapor pressure buildup in the tank. The tank and its bottom plate momentarily lifted, severing anchor bolts, before settling back. Subsequently, the shell-to-roof frangible joint failed, displacing the roof horizontally by about 1 meter. The top hand railing broke at multiple locations, the rooftop platform was damaged, and stairway grating with its support structure fell to the ground.

- All rooftop appurtenances were displaced or damaged. The dip hatch housing assembly, PV valve mounting assemblies, and HLS assembly were observed leaning in the same direction.

- The concrete ring beam foundation of the tank was fractured at multiple points.
- Of 17 anchor bolts, 10 were damaged and 2 were missing. Several bolts were severely corroded and thinned out. Anchor bolts were not checked during the last inspection.

- The tank had three earthing points, two taken from anchor chairs instead of using austenitic stainless steel grounding lugs on the shell.
- Earthing cables of rooftop instruments were found hanging along the stairway.

- Earthing bonding jumpers were not provided at multiple flange joints of MOV and ROSOV in the tank inlet pipeline.
- Inlet ROSOV and MOV cables were damaged by fire. The push button and indicator cover mounted on the ROSOV were also fire-damaged.
- The fixed foam pourer feeding pipeline was disconnected inside the dyke for modification work while the tank was in normal operation.
- Several flameproof enclosures inside and outside the tank dyke had compromised flameproof integrity.

- Modifications to the PV vent design and changes in receipt flow rate were made without recalculating venting adequacy. The added silica gel trap and flame arrestor likely restricted the P&V valve capacity, causing abnormal vapor pressure and tank explosion.
- Post-explosion, the frangible joint failed, displacing the roof and damaging appurtenances, including the expansion line. This led to ethanol spillage, with probable ignition from metal-to-metal friction, allowing fire to spread from the tank top to the bottom manifold.
- Roof displacement also ruptured the 1-inch expansion line at multiple points, spilling ethanol over the inlet ROSOV and into the manifold area. Compromised FLP enclosures inside the dyke (ROSOVs, MOVs) resulted in ethanol vapors igniting.

- Adequacy of tank venting and design calculations shall be verified for any modification in the PVRV arrangement of storage tanks. The design shall also incorporate provisions for a silica gel trap and a flame arrestor for ethanol tanks while determining vent size adequacy.
- All the operations shall be carried out as per SOPs.
- Product storage tanks and thermal expansion pipelines shall be inspected and maintained.
- The flameproof enclosures shall be inspected for FLP integrity and that records are maintained.
- ROSOV cables leading to the control room shall be fire resistant.
- The tanks earthing shall be provided through grounding lugs and grounding lug material shall be austenitic stainless steel when attached to carbon or low alloy steel parts.
