## CASE STUDY

OISD/CS/2021-22/E&P/04

Title: Accident during calibration of SRV

Location: On-land Production Installation

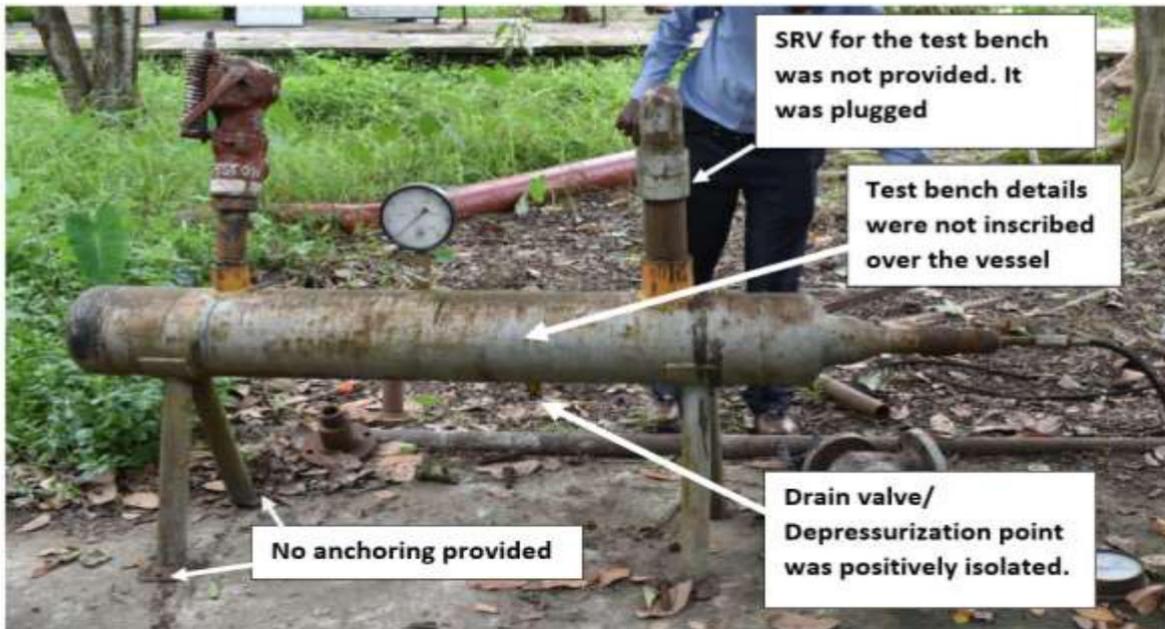
**Fig: The Test Bench**

- The Installation is an Oil Collecting Station and this location has locally fabricated pressure Test Bench for annual testing & calibration of various Safety Relief Valves and is being used since many years for testing & calibration purposes. The medium used for pressure testing is compressed natural gas connected to the HP NG header by a high pressure flexible hose, maintained at 80 kg/cm<sup>2</sup>.

- The accident happened with loud sound and Test bench fell on ground with one of the load spring of SRV detached. IP was found lying on ground on his back.

- One of the load spring of defective SRV coming out of spring retainer at high pressure resulting in sudden release of pressure with loud sound causing fall of unsecured test bench assembly and hitting the victim.

- The depressurization point of the unsecured Test Bench was kept blinded.
- The history of SRV under testing, which was earlier set at high pressure and was kept in not-in-use condition due to leakage observed at high pressure, was not made available to testing team.

- The test bench should always be kept properly grounded / anchored for high pressure tests and area should be properly guarded. Barriers/shielding must be used particularly for high pressure gas tests.

- No safety by-pass like plugging of Depressurization nozzle shall be allowed. Such safety points shall be thoroughly checked prior to testing.
- Only those pressure gauges shall be used, which were calibrated within the previous six months. The selection of Pressure Gauge shall be such that the operating range falls in the middle 1/3rd of the dial. That is, the maximum range shall be double the operating range to enable reading the gauge correctly.
