## SAFETY ALERT

OISD/SA/2020-21/P&E/01

Title: **Fatal incident due to fall from height**

Location: **Refinery**

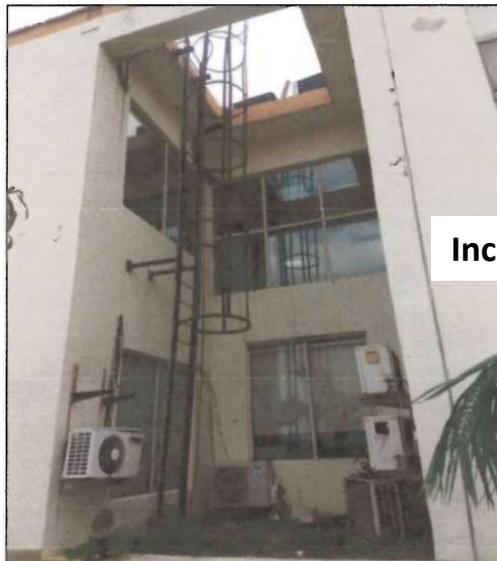
Incident Site

- The ladder was found firmly secured at the base and side wall of the building. The ladder was wet due to intermittent drizzling on the day of incident.

- This monkey ladder ran straight without any landing platform in between. When checked, it was found that the ladder top was improperly designed and made difficult to land/ ascend on the roof and descend from the roof.

- A low height (300 mm) parapet wall of building roof also made ascend/ descend to/from the roof difficult and posed a danger of accidental fall.
- While descending, there was a possibility of the leg getting entangled between parapet wall and the top rung of the ladder.

- No maintenance job to be carried out without proper permit to work.
- Rectification of defective design of caged monkey ladder w.r.t. following points on immediate basis.
  - a) Arrangement of safe and standard landing from top rung to building roof to be made.
  - b) Top rungs fouling with wall to be removed and remaining rungs to be realigned uniformly.

- c) Hand rail/ Landing platform to be extended ahead/beyond the parapet wall. Parapet wall height to be extended and a U-shape cut near landing to be made to allow smooth landing.
  - d) Self-closing swinging gate at the monkey ladder landing to be provided.
- Landing platform to be provided at every 6 meter or less height.
  - Review of Design and condition of Monkey ladders installed at other locations to be done by competent authority and ladders to be certified safe to use; defects if any to be corrected. Any ladder with structural or other defects is to be immediately tagged "Dangerous: Do Not Use" and removed from service until repaired or replaced.
  - Wherever total length of the climb on a monkey ladder equals or exceeds 24 feet, fall protection system to be installed.

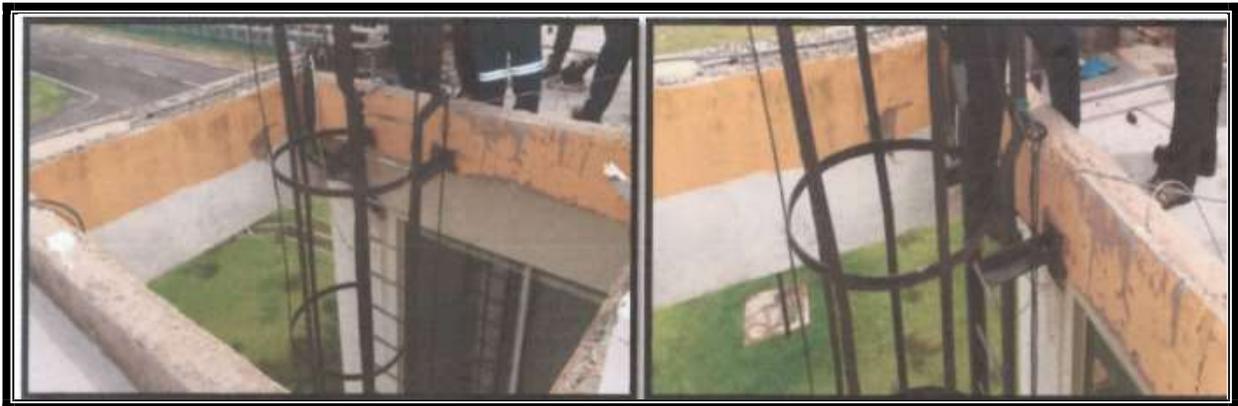
- At the top conjunction point of monkey ladder and roof, side hand rail of the ladder provided a support for balancing the body while ascending on the roof. But, while descending from the roof (parapet wall) on to the ladder, there was no hand rail support to facilitate firm three point contact, which may lead to imbalance / slip and fall.

**Top of caged monkey ladder – Defective landing/difficulty faced during ascending and descending**

- The leg of the victim might have got entangled between the ladder top rung and parapet wall and/or loss of three-point contact due to non-availability of hand rail while descending were the most probable causes of the incident.
- The root cause of incident was fall from height most likely while descending through the caged monkey ladder due to defective monkey ladder landing & design.
