## सेफ्टी अलर्ट / SAFETY ALERT

OISD/SA/2026-27/MOLPG/06

- Title:** Fatal Run-Over Accident Involving TT Driver During Movement of Bulk LPG Tank Truck in TTPA
- Location:** LPG Bottling Plant- Tank Truck Parking Area (TTPA)
- Activity:** Movement and parking of bulk LPG tank truck in TT Parking Area.
- Loss/ Outcome:** Driver of another bulk LPG tank truck was run over under the rear wheels of a moving tank truck resulting in fatality.

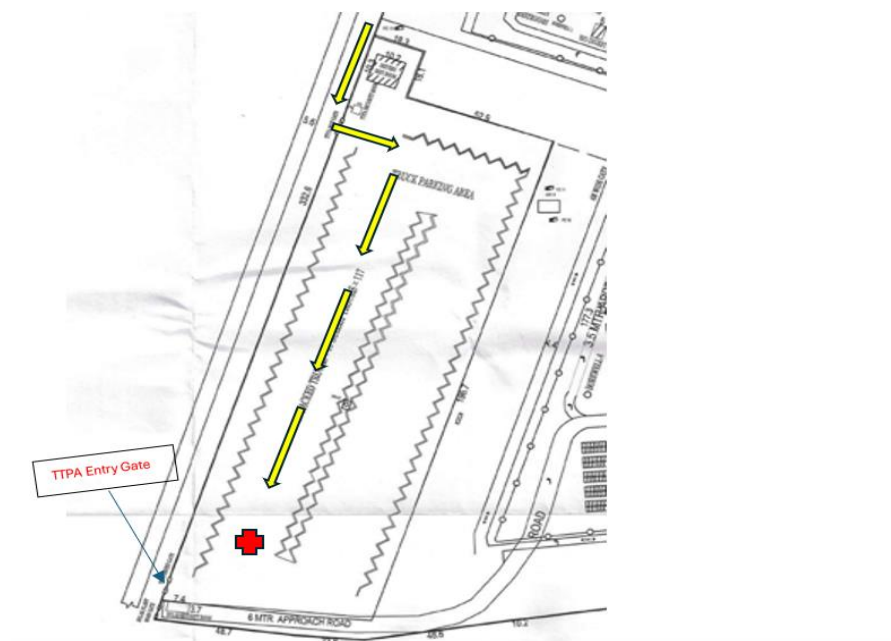
**Pictorial Display of Fatal incident location in the TT parking area**

On 12th February 2026 at around 19:42 hrs, a bulk LPG tank truck (TT), after reporting at the main gate, proceeded to the Truck Parking Area (TTPA) for parking. The vehicle entered the TTPA through the exit gate and was moving along the first driveway in search of a vacant parking slot, as all slots on either side were occupied. Unable to find any available slot, the driver reached at the end of the driveway. At that point, he heard an unusual sound from under the vehicle and immediately brought the TT to halt. Upon inspection, it was observed that the driver of another tank truck had come under the first set of rear right tyres of the trailer near the parking slot where his TT was parked. Nearby another driver rushed to the spot and the incident was reported to the plant officials by security.

The accident location is marked with a red “+” sign in the layout

- Ensure strict vehicle discipline in the TTPA and permit entry/exit of tank trucks only through designated gates.
- Ensure all bulk and packed TTs are parked only in designated parking slots in drive-out position.

- Ensure reversing and parking of TTs only under marshalling supervision.
- Ensure segregation of pedestrian and vehicular movement through signages, glow signs, blinking lights and speed breakers at crossing points.
