FATAL ACCIDENT AT WORKOVER RIG DUE TO FAILURE OF CASING LINE

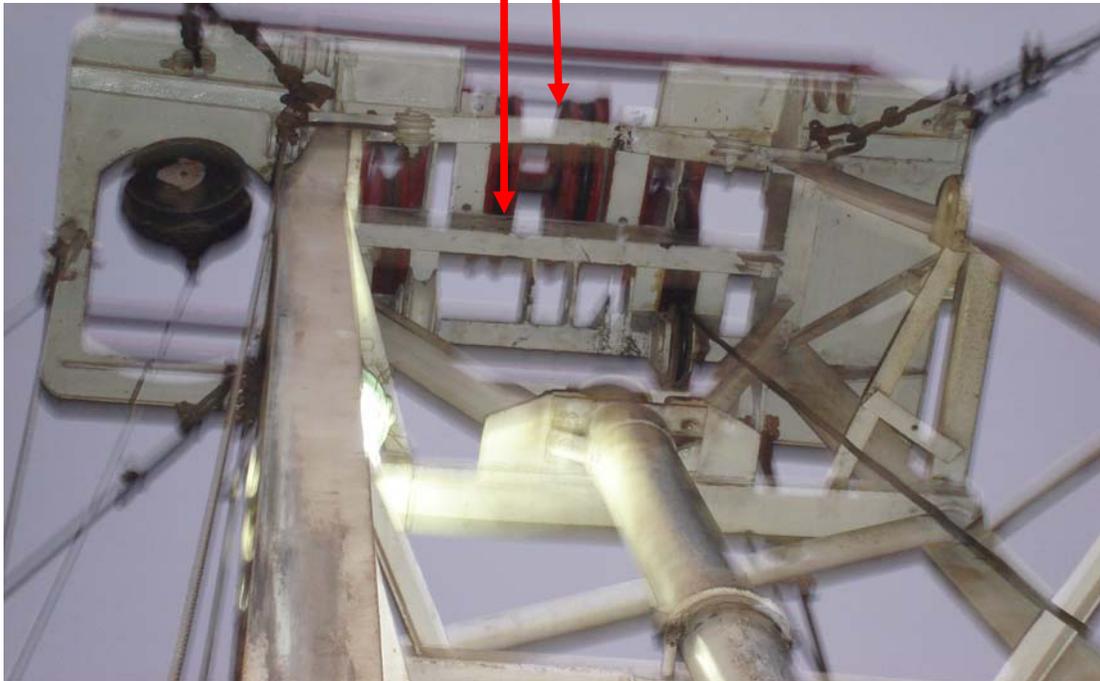
- iii) Damage observed on the crown block members, monkey board, travelling block and derrick floor area.
- iv) Derrick floor was very congested with number of equipment lying there.

Damage on crown block members

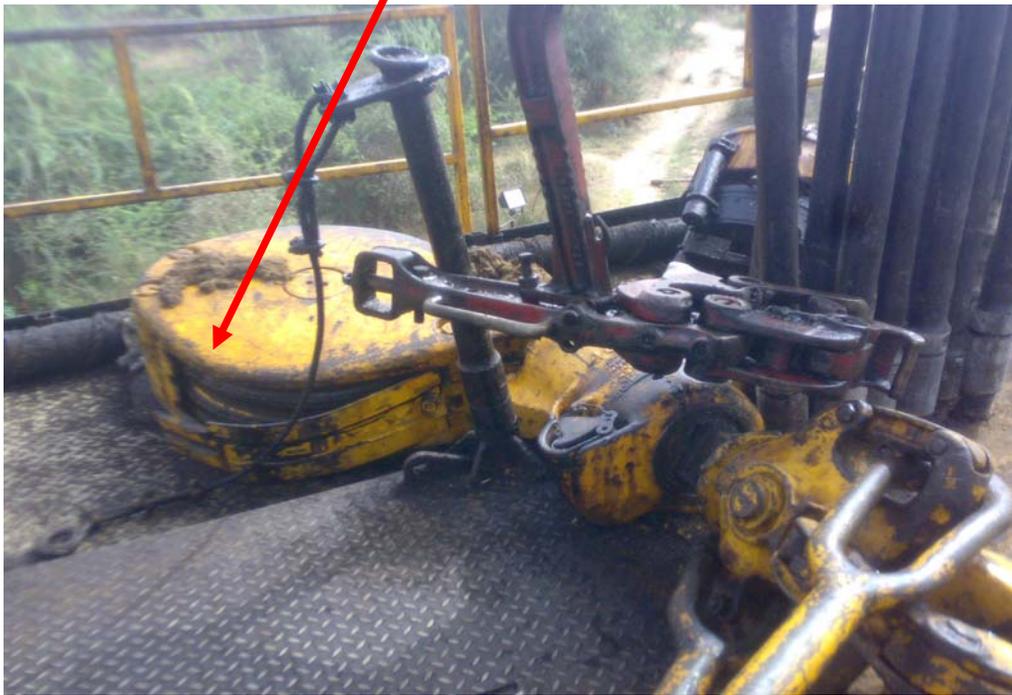
Damage on travelling block
