Investigation report on GGS fire incident

A major fire incident took place at Heater Treater unit of a GGS at around 2120 hrs.

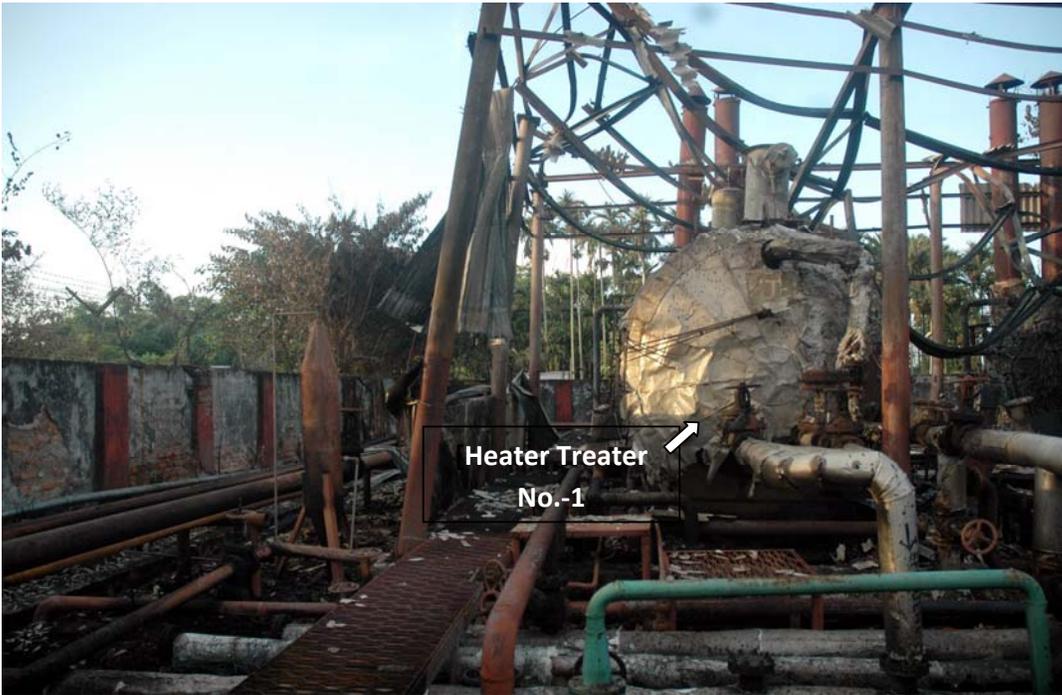
Heater treater Area

Heater treater shed area was cordoned off by local police authority for collecting samples for forensic analysis; hence heater treaters could not be inspected closely during the investigation. However, the damage to the heater treaters appeared to be external.

- i. Heater treaters are located very close to the boundary wall of the installation. Inter-distance requirement as per OISD-STD-118 is not being met and this was pointed out by OISD audit team which visited

the installation in July, 2010. Also, there was a lot of crude oil spilled in the area

Though the exact source of ignition could not be ascertained, as the area of fire ignition is very close to the boundary wall, the possibility of source of ignition being external (from outside the boundary wall) cannot be ruled out. [Incidentally, based on forensic analysis, concerned state authority have ruled out the use of explosives, as per the information received later on] There was sign of considerable amount of crude oil spillage near the heater treater area which fuelled the fire, and crude oil in storm water channel caused the fire to spread from one corner of GGS to another.

- I. The process equipment should be relocated to safe area, maintaining the inter-distance requirements as per OISD-STD-118 on 'Layouts for Oil and Gas Installations'. Alternately, additional control measures should be put in place, based on quantitative risk assessment.
- II. Engineering and procedural control measures should be taken to avoid the abnormal spillage/leakage of crude oil.
- III. Crude oil in storm water channel is unacceptable. Immediate measures to be taken to stop spillage of crude oil in the storm water channel.
- IV. Housekeeping in the plant need lot of improvement.
