**Underground Blowout Control  
at Well NHK# 285  
OIL, Assam.**

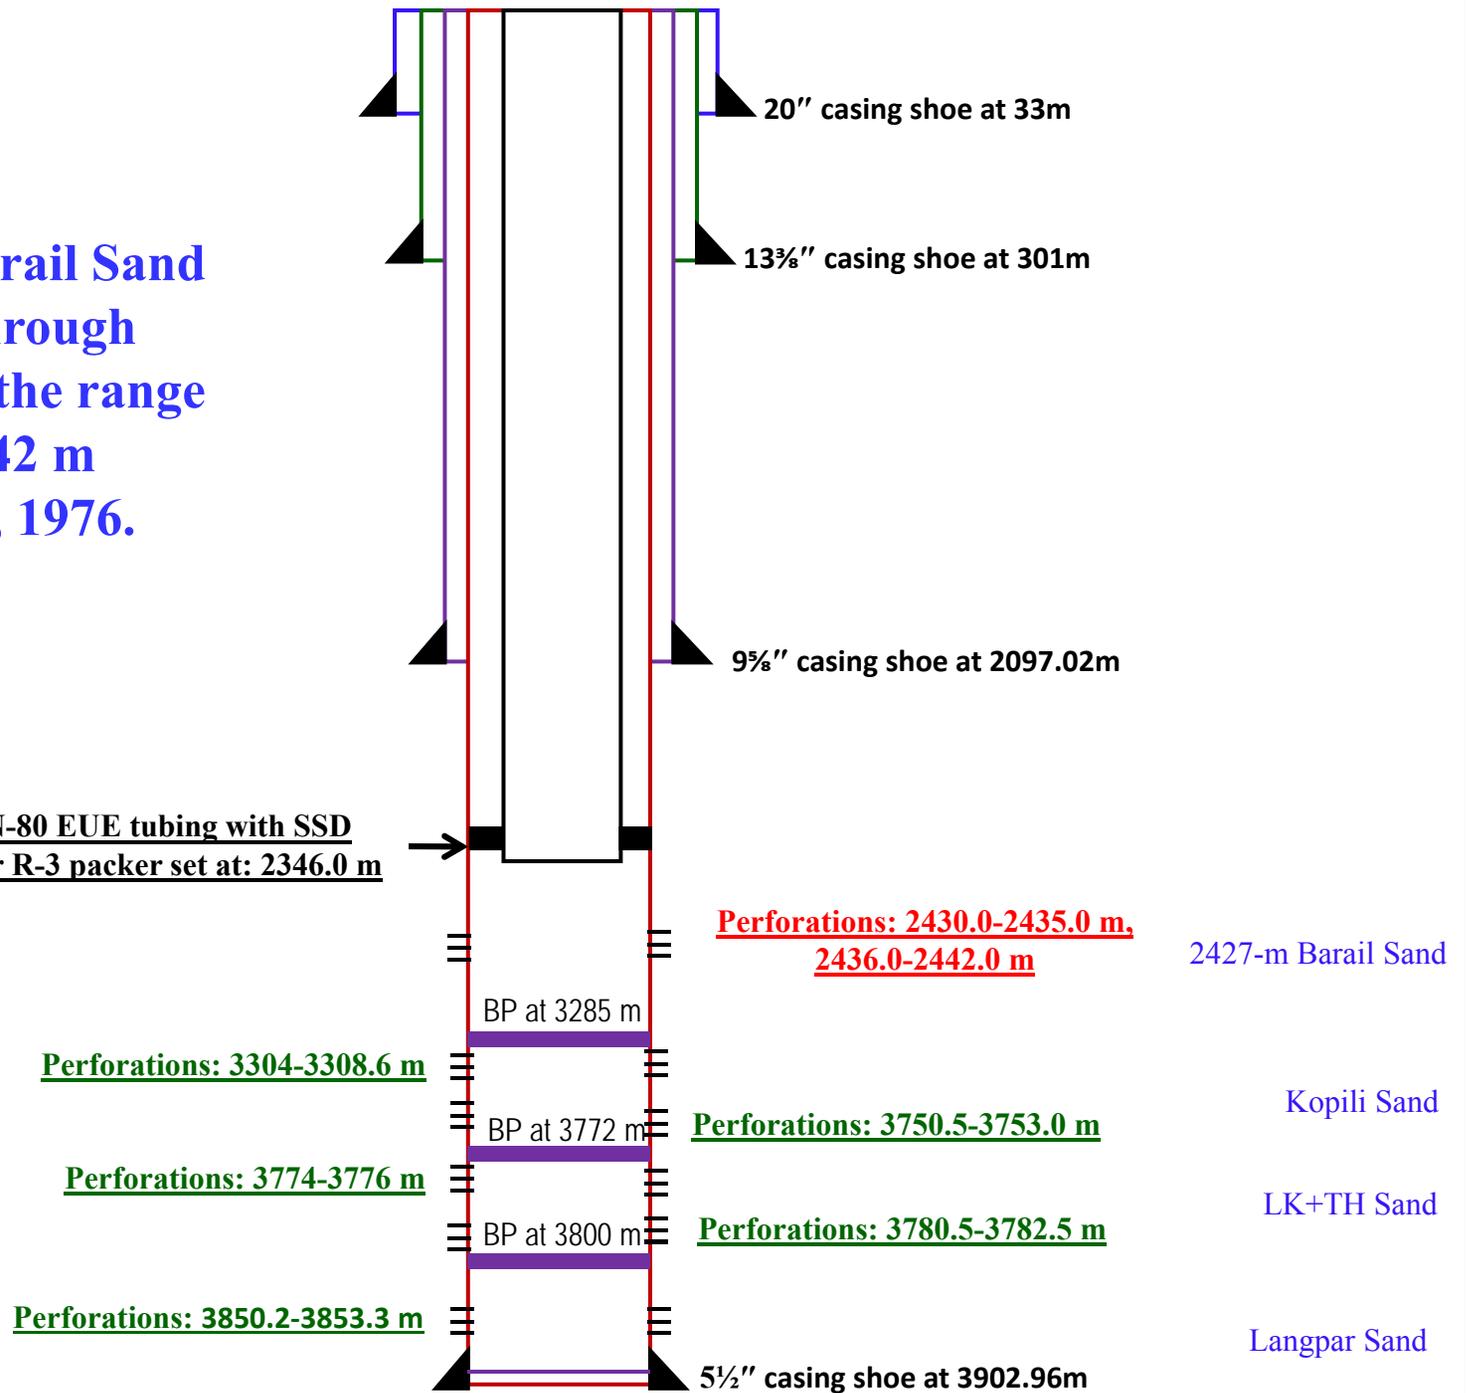
**2427-m Barail Sand  
was tested through  
perforations in the range  
2436m -2442 m  
on 21<sup>st</sup> Aug, 1976.**

**2.7/8" OD N-80 EUE tubing with SSD  
FB HW Baker R-3 packer set at: 2346.0 m**

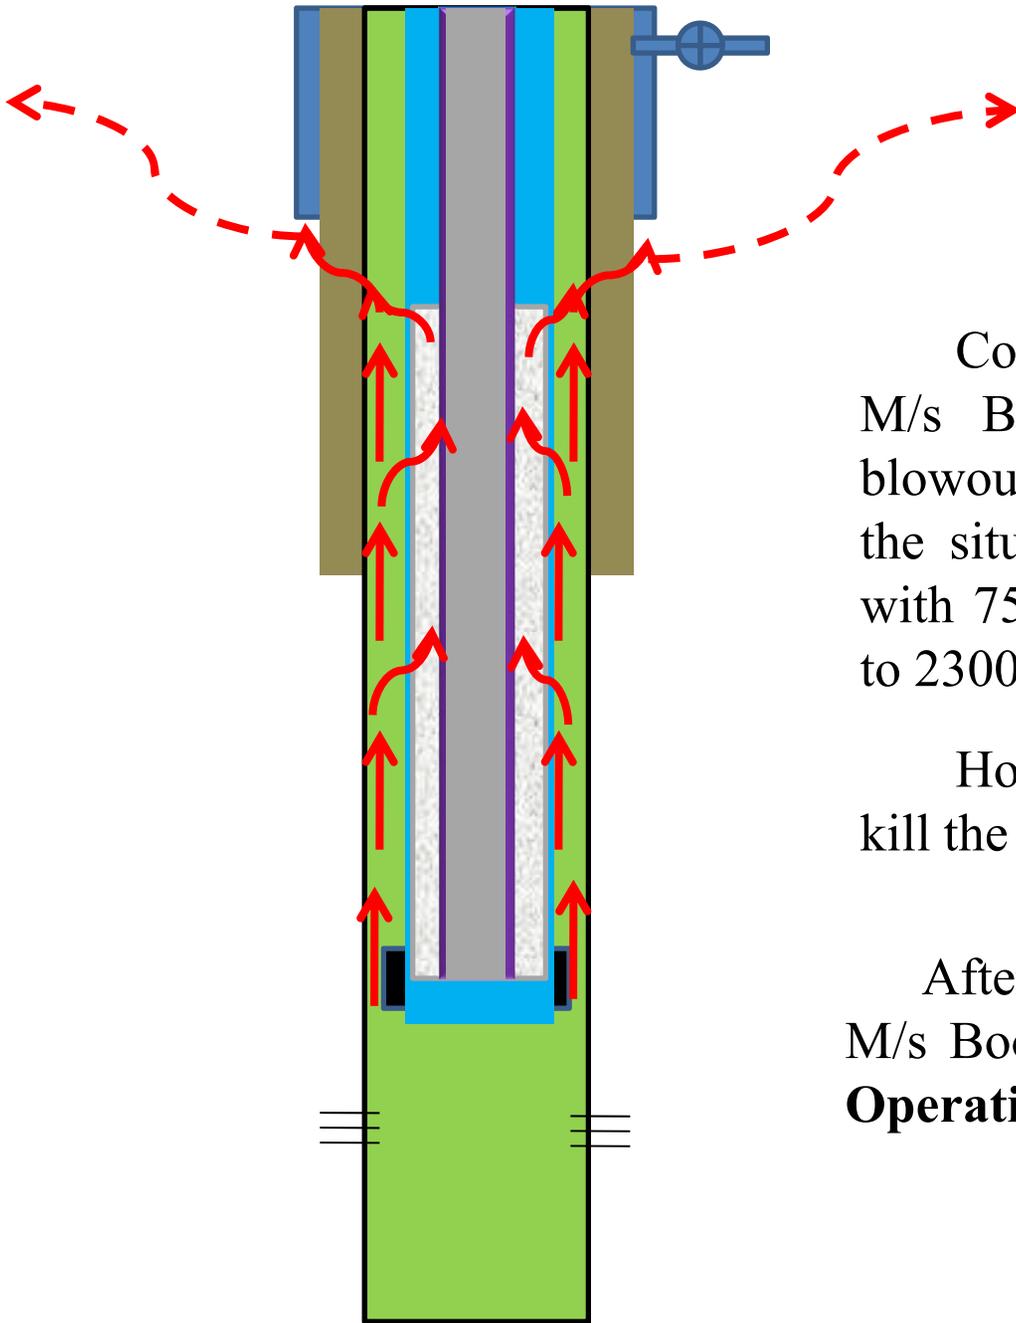
During the 2<sup>nd</sup> week of December, 2011, surface broaching of gas at around 1.5 km away from the well NHK#285 in N-E direction was reported and there was a fire incident in night hours on 31<sup>st</sup> Dec, 2011.

Subsequently, in the first week of January, 2012, surface broaching of gas was noticed at an area about 1 km away from the well in N-W direction .

Gas sample was collected from these spots and it was found to be of similar composition as of NHK#285 gases.

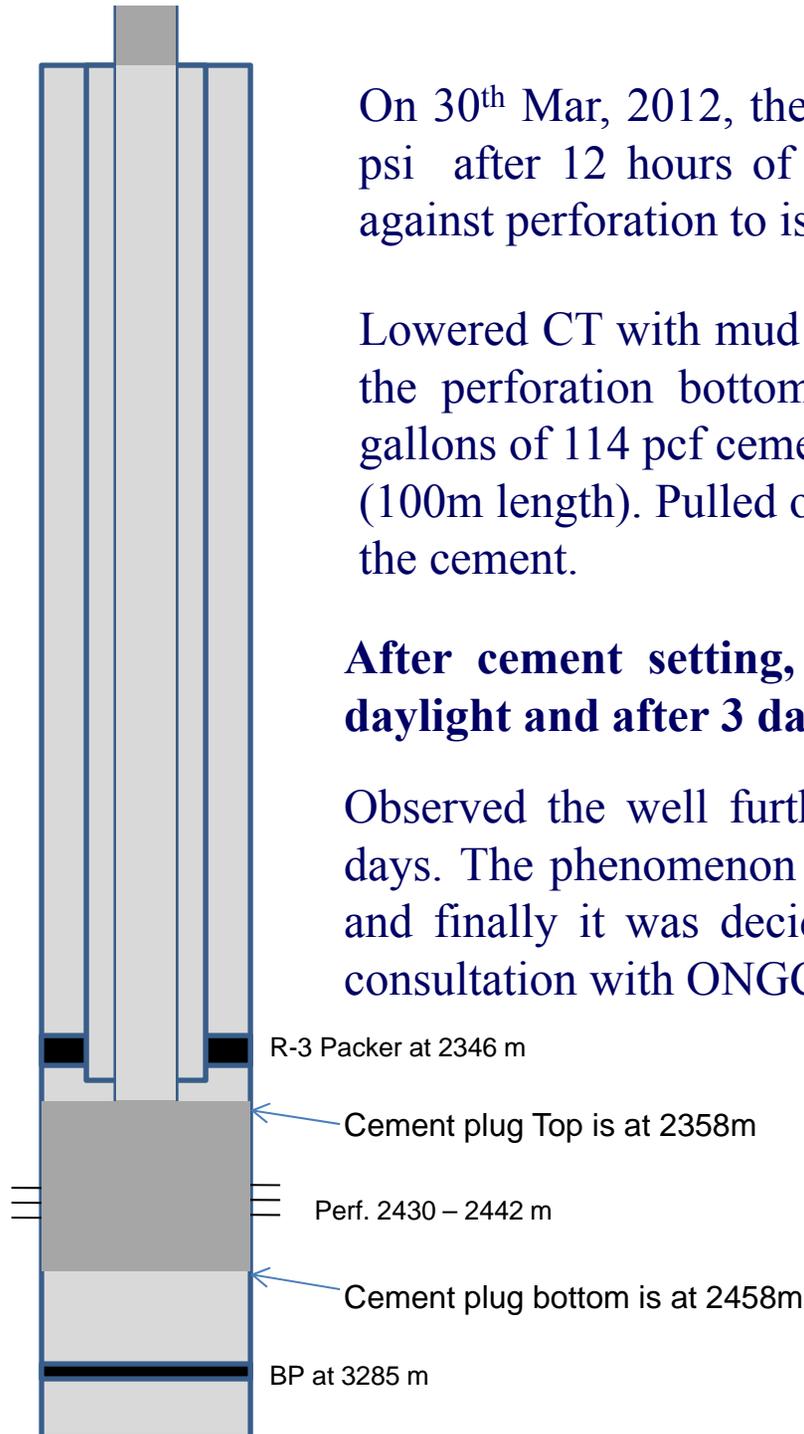
After half an hour of observation, the wellhead pressure became stable at 250 psi which was expected back pressure from the charged formation. However, the well kept shut-in overnight for further observation. It was decided not to pump mud further which may push back charged gas away from the well and contaminate nearby water bearing zone.

On 30<sup>th</sup> Mar, 2012, the wellhead pressure was found to be stable at 250 psi after 12 hours of observation and decided to place a cement plug against perforation to isolate the producing zone.

Lowered CT with mud circulation and got held up at 2458m, 16m below the perforation bottom (perforations: 2430m – 2442m). Pumped 270 gallons of 114 pcf cement slurry and placed a plug from 2458m to 2358m (100m length). Pulled out CT and kept the well shut-in for 48 hours to set the cement.

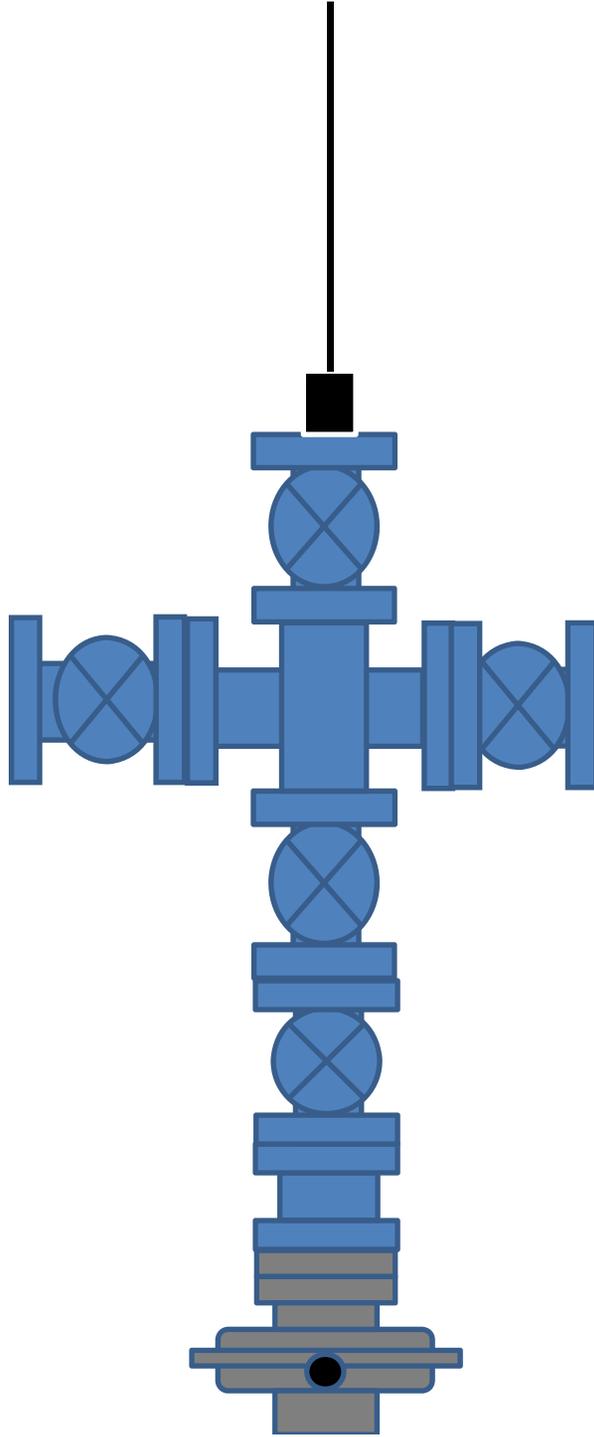
- Aging of the well (35 years) and /or production of gas with sand content for a long duration (July 2010 to 14.07.2011) might have caused erosion added to corrosion leading to loss of tubing and casing integrity.

- As per recommended practice, gas tight (premium threaded) casing and tubing should be used in gas wells completion. But, this well was completed with round threaded casings and tubing. This could have led to leakage in the thread connections of the tubing and production casing string.

- 78 pcf Salt Solution ( $\text{CaCl}_2$ ) was the packer fluid since October, 2005, which might have accelerated tubular corrosion leading to loss of tubular integrity.

- Annular pressure build-up was not addressed in time – 5½" pressure was recorded as 2700 psi (190 kg/cm<sup>2</sup>) on 9<sup>th</sup> September, 2009 and 9<sup>5/8</sup>" casing pressure was recorded as 1160 psi (82 kg/cm<sup>2</sup>) on 1<sup>st</sup> May, 2010. But, proper action was not taken to address these unwanted pressures.

- Prolong attempt to arrest loss circulation and inexperience in pumping heavy mud & cement slurry through Coiled tubing led to delay in operation and aggravated the situation.
