CASE STUDY

OISD/CS/2026-27/P&E/08

Title: Fire Incident in Crude and Vacuum Distillation Unit (CDU/VDU)

Location: Refinery

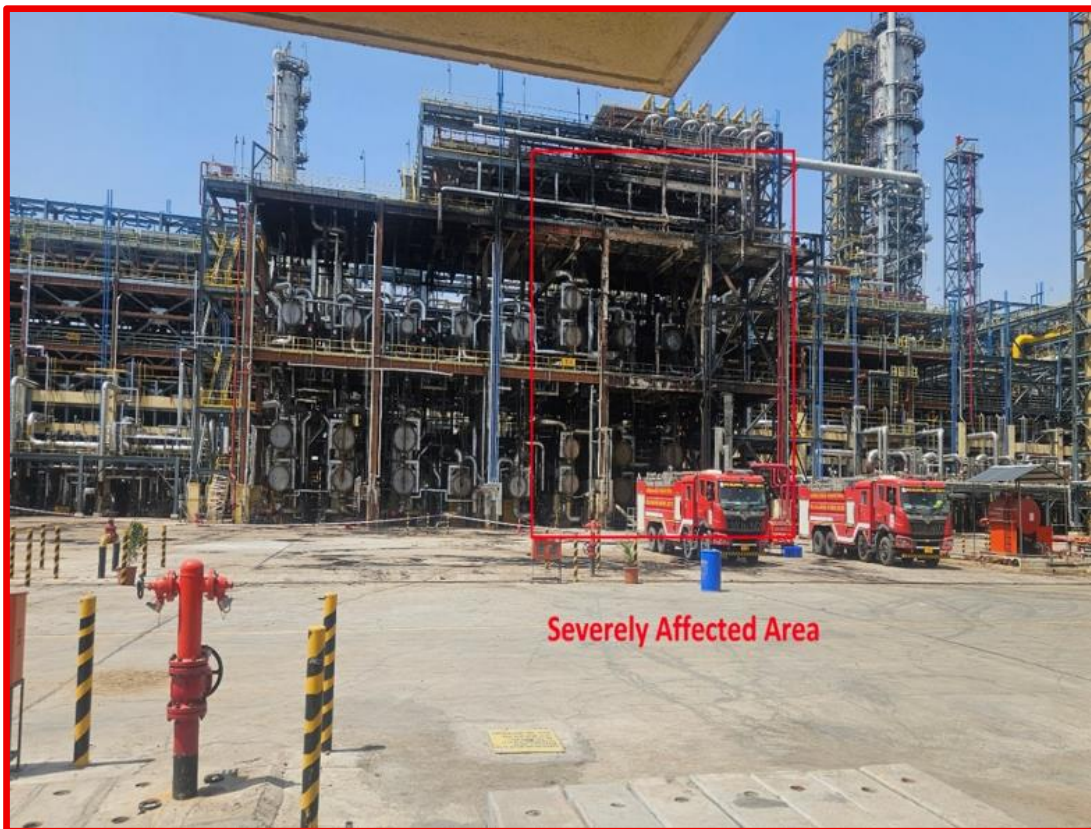
7. Dripping and minor leakage of VR stream (predominantly RCO) was also noticed from the gland area of the vacuum residue (VR) inlet gate valve of the same crude versus vacuum residue exchanger. Displacement of the gland packing and gland follower assembly of the valve was identified. The eye-bolt nuts were found disengaged and outward thread deformation was noticed on the gland flange studs, indicating additional leakage through the gland opening during the incident.

8. The vacuum residue (VR) inlet isolation gate valve was found maintained in a partially open condition without backseat engagement, resulting in continuous process pressure acting on the gland packing arrangement and making the gland more susceptible to leakage.

Failed Valve Gland Assembly – Additional VR Leak Source Sustaining the Fire
