## SAFETY ALERT

OISD/SA/2020-21/E&P/03

Title : Accident Due to Failure of DP System.

Location : E&P Offshore

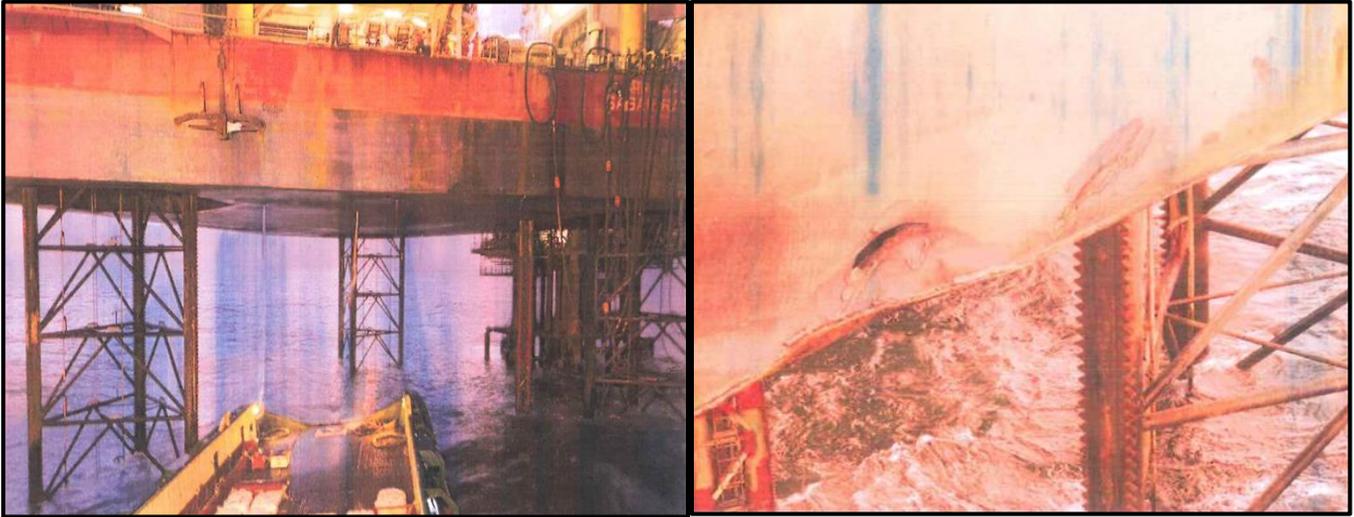
- Damage at starboard quarter from crash rail to top and bottom steel fenders.
- Damage to exhaust uptake of both main engines on mast deck.
- Observed deformation in the support pipe of main mast.
- Damage also sustained in under water area and starboard fuel oil tank due to contact with the forward leg.

**Rig damage:** Damage was found in the hull due to impact.

The vessel completed the checklist and entered 500 meter zone at 05:48 hours and was under the port crane of the rig at 06:10 hours. At that time Rig heading was 340 degrees and vessel heading was 256 degrees with the stern towards the rig. Chief Officer and 2<sup>nd</sup> officer were on duty at bridge. Suddenly, the starboard propeller got deselected from DP console. In this situation, the duty officers attempted to switch the controls to manual mode with the intension of pulling out the vessel safely but in doing so the controls were not effectively transferred to the aft console. In the interim, devoid of any control the vessel continued to drift under the influence of weather, till the stern made contact with the starboard leg and simultaneously, the funnel and mast also made contact with rig's hull. Subsequently the star board side made contact with the rig's forward leg. Controls were finally transferred to the forward console on manual mode and the vessel was pulled out at 06:12 hours under her own power. Vessel maneuvered to safe distance and carried out damage assessment and noted as below:
