## CASE STUDY

Title: Accident at modular rig.  
Location: Offshore.  
Loss/ Outcome: Expelling of tubing hanger along with wireline assembly from Wellhead causing injury to 4 persons.

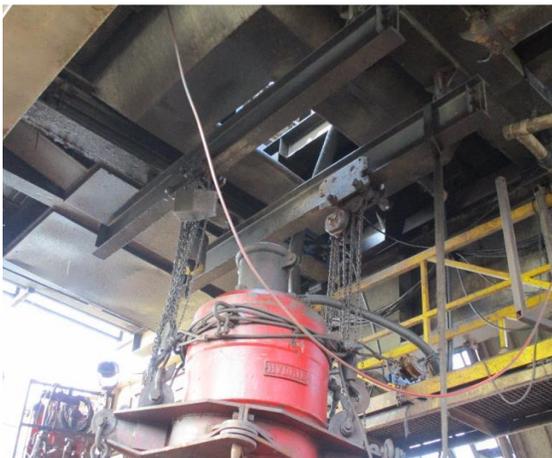
The ALFA tool was made up and lowered inside the slick line lubricator. Gas injection through A-Section was carried out and the B-Section of wellhead was kept open through burner boom. At this stage there was a sudden surge of pressure in the well due to which the landing joint with wire line lubricator, tubing hanger, rotary table and bushing were flung out. The incident caused injuries to four persons who were present on the rig floor.

**Missing bell nipple & rotary table**

- ❖ All wireline jobs should be carried out after adequate tightening of anchor bolts on tubing hanger as per OEM recommendation.
- ❖ X-mas tree should be preferably on the wellhead for execution of such specific jobs. In case X-mas tree is replaced with BOP, pipe ram should be kept in closed position.

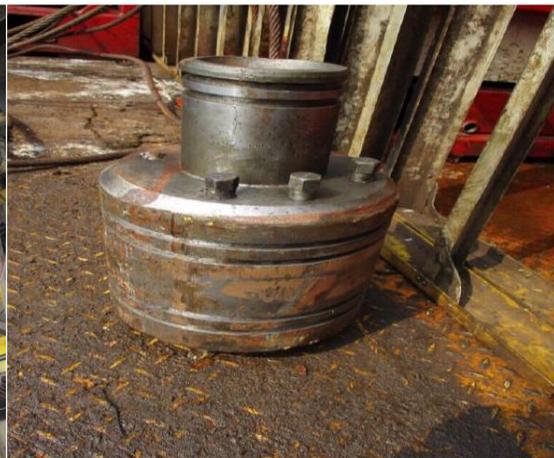
- ❖ Anchor bolts of tubing hanger were probably not fully tightened as evident from marks at only 3 places on periphery of tubing hanger.
- ❖ There was no detailed plan for the job mentioning maximum permissible injection pressure which can be subjected safely.

- ❖ The risks involved in carrying out logging job in pressurized 9 5/8" casing (Gas injection in section A) without a defined return passage (Through suspected leakage in section B) was not anticipated by any of the persons involved in the operation. The gas injected at a high pressure caused an upward thrust on the tubing hanger and lifted it out from the well head.

**Tubing hanger with abrasion marks**
