CASE STUDY

Title: Uncontrolled flow of gas from a well.
Location: On-land
Loss/ Outcome: Snapping of flow line, injury to 1 person.

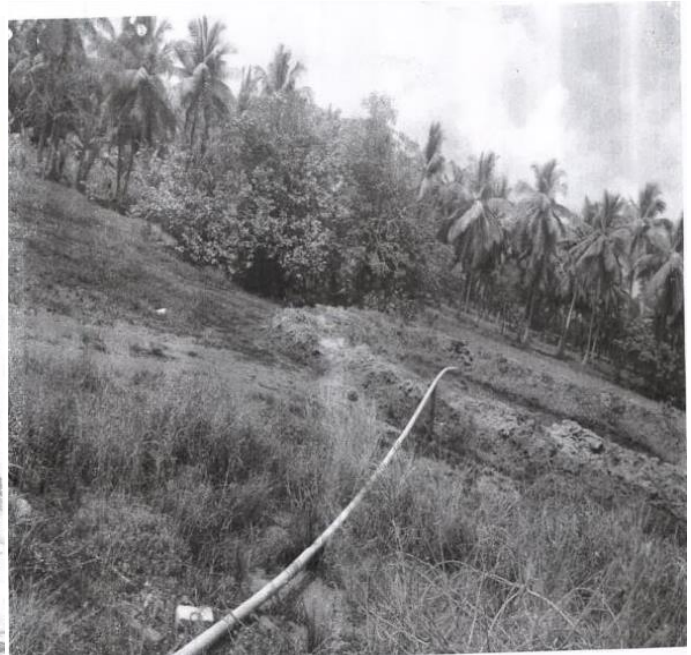
Flow Line to Waste Pit

- ❖ Well activation job was not being carried out as per the plan.
- ❖ MS pipe with locally fabricated joint was used in flow back line in place of high pressure steel tubular with standard joints, which parted away due to high gas pressure.
- ❖ Flow back line was not anchored.
- ❖ There was no choke manifold connection between the X-mass tree and flow line.

- ❖ Well activation shall be planned considering all possible hazards and their mitigation measures.
- ❖ Flow backline shall be made up of high-pressure steel tubular.
- ❖ The flow line shall be suitably anchored to prevent whiplash in the event of gas flow during activation.
- ❖ Choke manifold shall be connected between the flow line and X-mass tree.
- ❖ Separator, gas flare line and flow back measuring tank shall be included in the list of minimum equipment required prior to well activation.
- ❖ ERP shall be prepared in advance and emergency mock drill shall be carried out.
- ❖ The availability of breathing apparatus and firefighting arrangement shall be ensured before the commencement of the activation job.
- ❖ All wells shall be temporarily abandoned as per OISD-STD-175.
