## SAFETY ALERT

**INCIDENT:** Two contract workers were engaged to shift Electrical scrap material in a trolley, in an open road at Co-Gen Plant. The trolley was moved by hand, with one contract worker at the front and one at the rear of the trolley. Suddenly, there was loud sound, heard during the movement of the trolley, in the middle of the road. The contract worker at the rear of the trolley had injuries in the left fingers, right leg, chest and face. He succumbed to his injury later on. The other worker did not suffer major injuries.

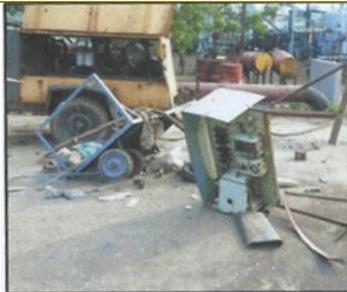
SITE PHOTOGRAPH:1

**OBSERVATIONS:** One piece of the Container had the details "PHOS A 85" with Manufacturing Date September 2010 was found near the spot.

**ROOT CAUSE:** "PHOS A 85", later identified as "Phosphoric Acid", was unused for a long time period and would have been in decomposed state. While carrying the scrap material, the Container may have fallen down. While pulling the Container back into the trolley, the pressure developed due to its decomposed form and agitation of the Container would have led to the Container bursting open. The chemical, coming in contact with the metal trolley, would have resulted in a violent exothermic reaction. The impact had formed a cavity in the road and the rear contract worker, who was trying to lift it back, got injured seriously

**RECOMMENDATIONS:** (1) Scrap material contents (mainly chemicals) should be identified before disposal. (2) Ensure safe disposal of any unused material after completion of job. (3) There should be an monitoring system to monitor all the chemical coming inside the industry.
