SAFETY ALERT-LOCK OUT TAG OUT (LOTO)

INCIDENT: A contract workman carrying out mechanical Preventive Maintenance (PM) job on air fin fan cooler was hit by the blades of fan when it was accidentally started. He succumbed to his injuries.

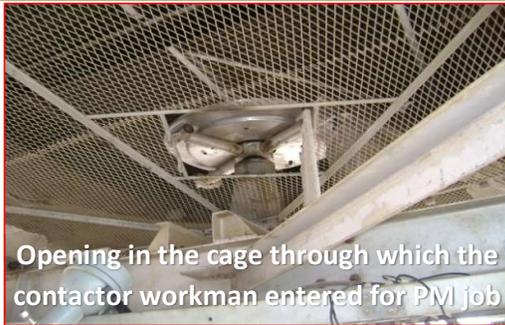
Opening in the cage through which the contractor workman entered for PM job

- (1) Fin Cooler Fan motor was having the problem of 'motor not stopping' from local stop push button.
- (2) On production Dept.'s written request, Electrical operation de-energised the motor and put the tag on electrical isolating device. Production Department handed over the motor to Electrical Maintenance for rectification.
- (4) Subsequently, Production handed over the same fan to Mechanical Maintenance for preventive maintenance job.
- (5) After completion of job, electrical maintenance started Fin Cooler Fan Motor directly from the electrical sub-station for ascertaining success of the rectification job. No clearance from Production Dept. was taken.
- (6) Fatal Accident occurred at the same instant, as a workman was on the job on the same fan for mechanical check.

ROOT CAUSE: (1) Lack of coordination between Electrical (Operation), Electrical (Maintenance) and Production Departments. (2) System of Lock Out and Tag Out (LOTO) was not in place.

RECOMMENDATIONS: (1) The practice of making direct request by Electrical maintenance to Electrical operation for energization of motor to take trial run to be stopped. The Electrical isolation /energization permit system should be followed for trial run also.

(2) Full proof multidisciplinary LOTO system (Lockout & Tag out) should be in practice.

(3) Implementation of Work Permit System as per OISD-105 for all jobs inside Refinery needs to be strengthened further.

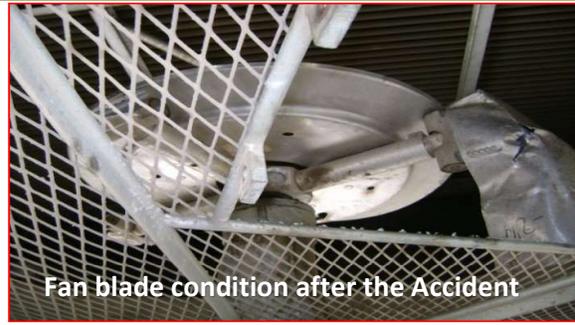
Fan blade condition after the Accident
