CASE STUDY

OISD/CS/2023-24/PL/12

Title: Pipeline failure incident in River crossing.

Location: River crossing.

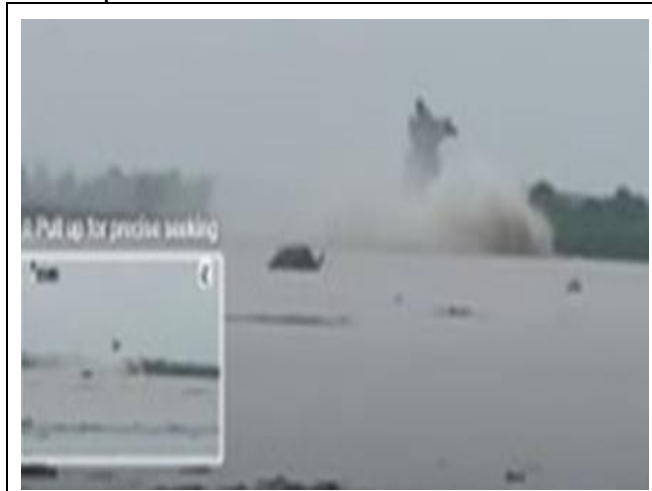
Later, information regarding gas leakage in river crossing was received through villagers approximately 35-40 mins after the fluctuations in monitoring parameters. The sectionalizing valves were closed for isolation of leak section and monitoring of the mainline pressure. The maintenance team reached the location and observed leakage from mainline in river crossing.

Leakage in river

Based on data and evidence collected, it can be concluded that lapses relating to the design and monitoring of river course, caused the pipe portion exposed to high stresses in tie-in portion, which led to its failure.

2. To the extent feasible, HDD should be done in single shot avoiding any tie in section within river channel. In case of constraint, the design of tie-in section shall be considering washout and mechanical protection in flood situation.

15. All pipeline operators shall consider tie-in section as the vulnerable portion of the HDD crossing and frequent watch to be kept to check any erosion on account of heavy floods during monsoon.

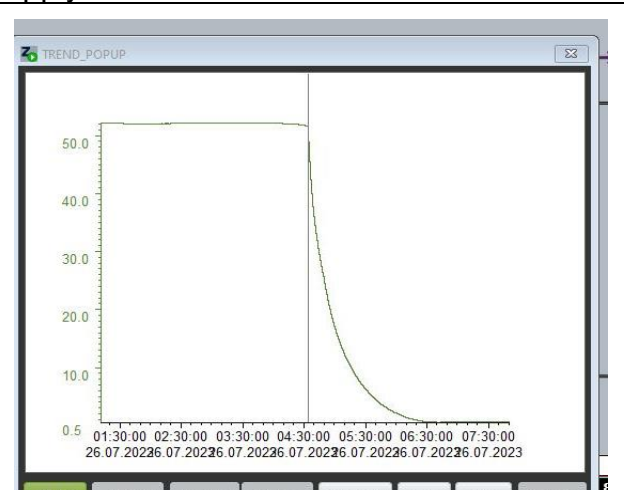
Pressure drop was observed in Natural Gas pipeline at various consumer ends and at intermediate Sectionalizing valve locations. The pressure drop was more significant between sectionalizing valves installed across the river crossing in the pipeline. There was gradual increase in flow in the pipeline at dispatch side and reduction of flow at receipt end. The Control room alerted the top management and mainline team was mobilized to field locations to verify the possibility of leak.

Pressure trend in SCADA at SV

5. Functioning of the Leak Detection System should be given more focus. All the pressure and flow data must be updated on real time basis in SCADA and monitoring format should be developed to verify on regular basis.
