## CASE STUDY

OISD/CS/2023-24/P&E/07

Title: Fatal Incident due to explosion of sample bomb.  
Location: Refinery  
Loss/ Outcome: One fatality

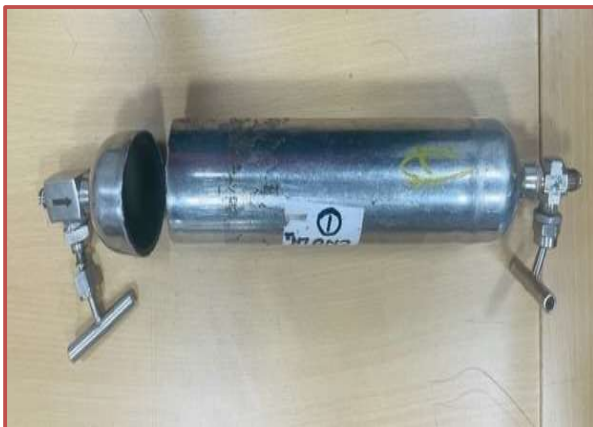
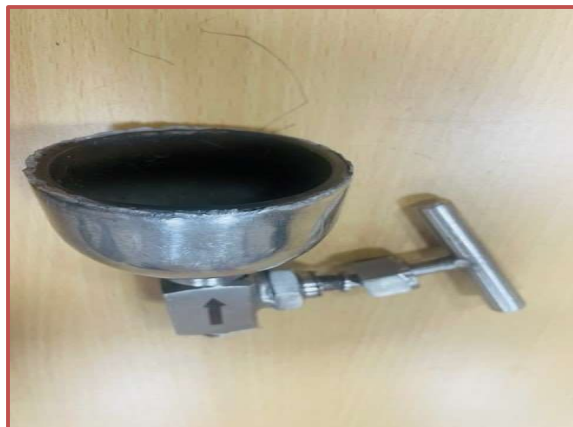
*Sample collection bomb after the incident*

4. Sample bomb exploded into two pieces. The dome portion of the bomb along with needle valve penetrated the upper left thigh of helper, who was standing beside the driver.

- On the day of incident, the liquid flow into the sample bomb must have been higher than that happening in earlier occasions (more by few millilitres). The sample bomb collected with liquid nitrogen was isolated/ sealed with the needle valves firmly on both ends. By virtue of contact with ambient air & atmospheric conditions, the liquid nitrogen in the sample bomb must have vaporised vigorously resulting in build-up of pressure in the sample bomb. Consequently, the bomb failed from the weld joint. Considering that the bomb had already been tested at 70.4 kg/cm<sup>2</sup>g, the pressure must have increased more than the test pressure.

- It is also likely/ probable, that dipping the bomb in water might have increased the heat transfer to the small quantity of liquid nitrogen in the sample bomb, as water is not as good insulator as air. Further the heat content in water is much higher than in air. So, these factors might have quickened the pressure build up.

Nitrogen Gas sample shall be taken instead of nitrogen liquid sample in line with the operating manual and standard practice. If liquid nitrogen sample is required, then appropriate collection device, suited for cryogenic services, is to be used.

- a) Use of the sample bombs whose OEM documentations/ engineering design details are not available, shall be suspended.
- b) OEM documentations/ engineering design details of equipment should be available as and when required.
- c) Hydrotest records shall be maintained in standard format.
