CASE STUDY

OISD/CS/2025-26/PL/15

Title: Gas leakage & Fire incident in Offshore section (near river mouth) of a Trunk Pipeline originating from Offshore Processing complex.

Location: Offshore section (near river mouth) of Trunk Pipeline.

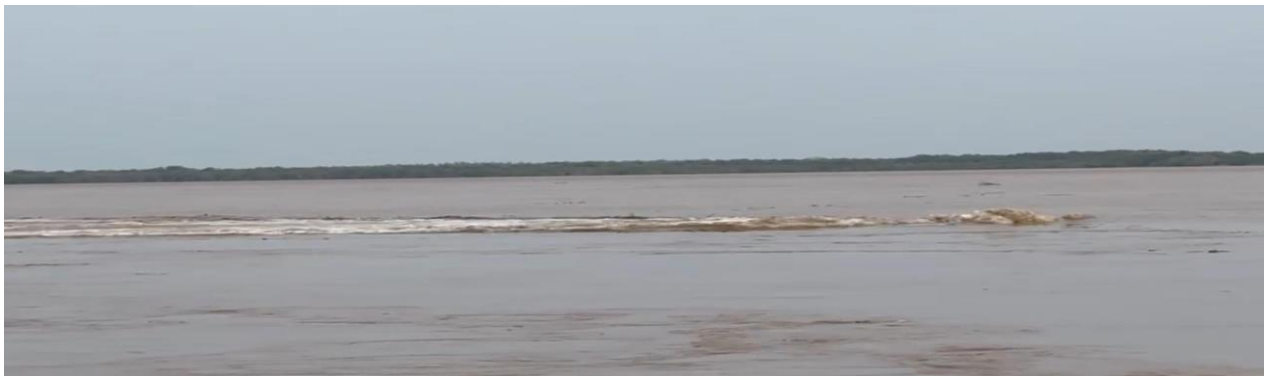
A sudden pressure drop was observed in an Offshore (Sub-sea & Sub-river) trunk pipeline which is used for transferring Gas along with condensate from an offshore Process Platform Complex to Onshore Gas Terminal. Immediately after pressure drop was observed, communication was established between process platform and Onshore gas terminal to ascertain the reason for pressure drop. Suspecting probable leakage in trunk line, gas flow to pipeline was stopped from process platform and depressurisation of the pipeline was started from both process platform and Onshore gas terminal ends.

During depressurisation of the gas pipeline, a fire was also observed at a point located approximately 400 m from the landfall point in the adjoining river mouth. This indicated a probable leak in the pipeline followed by ignition of released hydrocarbons.

After reduction of pressure, purging operations were commenced from Onshore gas terminal end using inert gas to displace any residual hydrocarbons within the pipeline. Fire was subsequently extinguished, after the complete isolation and cutting off gas supply from the source. No injuries, fatalities or third-party property damage were reported because of the incident.
