CASE STUDY

OISD/CS/2025-26/MOLPG/22

Title: Major accident while operating service water valve for topping up of soap solution tray used for lubricating conveyor chain.

Location: LPG Bottling Plant

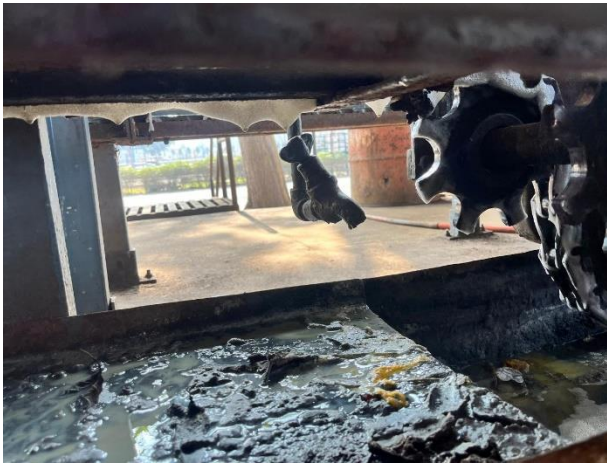
1. The IP (Injured person) operated the valve of service water line from beneath the conveyor on the other side of valve, without stopping the chain conveyor. This indicates an unsafe act and deviation from Standard Operating Procedure (SOP).
2. The isolation valve of service water line near the soap trays is positioned too close to the running sprockets
3. Approach towards the valve of service water line of soap tray of Drive Unit is very difficult due to the narrow clearance between the two conveyors, resulting in constrained and unsafe access to the valve.
4. The following unsafe act were observed from the CCTV footage:
 - a) IP was wearing a two-piece coverall with sleeves folded at both arms, resulting in loose end.
 - b) Many workers were seen using mufflers with loose ends.

Isolation valve position

- 2 **Relocation of isolation valve of service water line:** - Possibilities may be explored to position the valve at a convenient location away from the soap tray. Additionally, valve may be installed on both sides of the soap tray for easier access and safer operation.

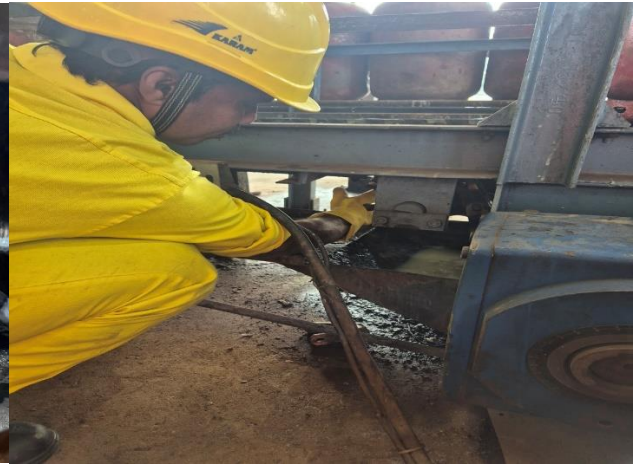
A contract workman was assigned the task of pouring soap solution and topping up of soap solution tray by opening the valve of service water line for chain lubrication. Instead of going to the other side of the chain conveyor where the valve of service water line was located, workman attempted to operate the valve from beneath the conveyor from the other side, without stopping the chain conveyor. This action caused his coverall sleeves to come into contact with the sprocket and further his hand near elbow also got trapped in the sprocket resulting in the amputation of his right hand.

Demonstration of act

- 3 **Sprocket Guard Installation:** - To install suitable safety guards on both sides of the sprockets to prevent accidental contact and ensure additional safety.
