## CASE STUDY

OISD/CS/2026-27/E&P/ 01

**Title:** Blowout after well perforation.  
**Location:** Onshore workover rig.  
**Loss/ Outcome:** Blowout.

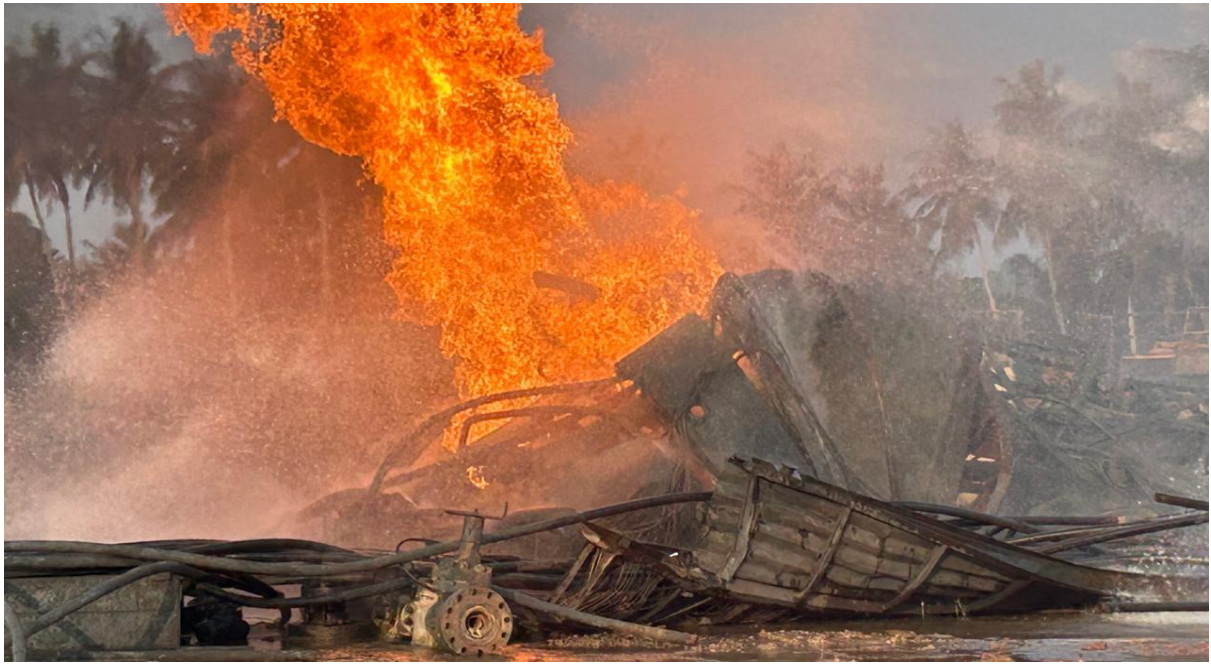
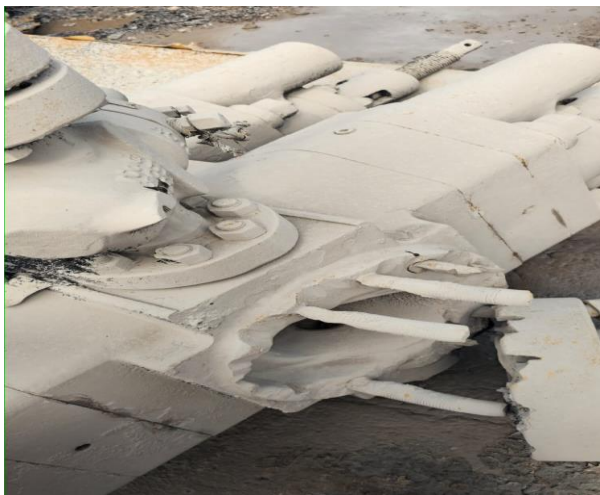
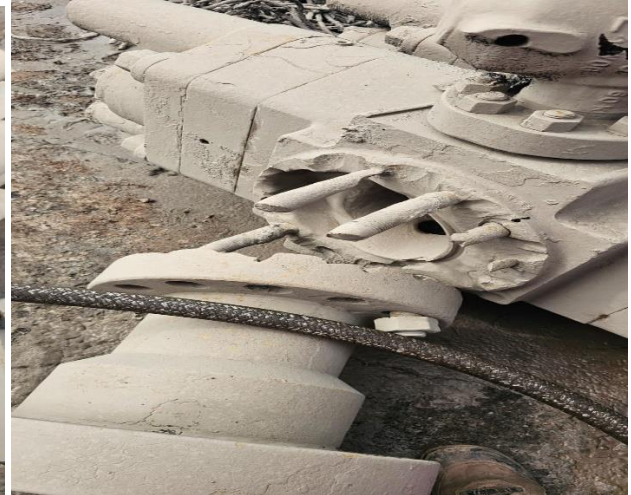
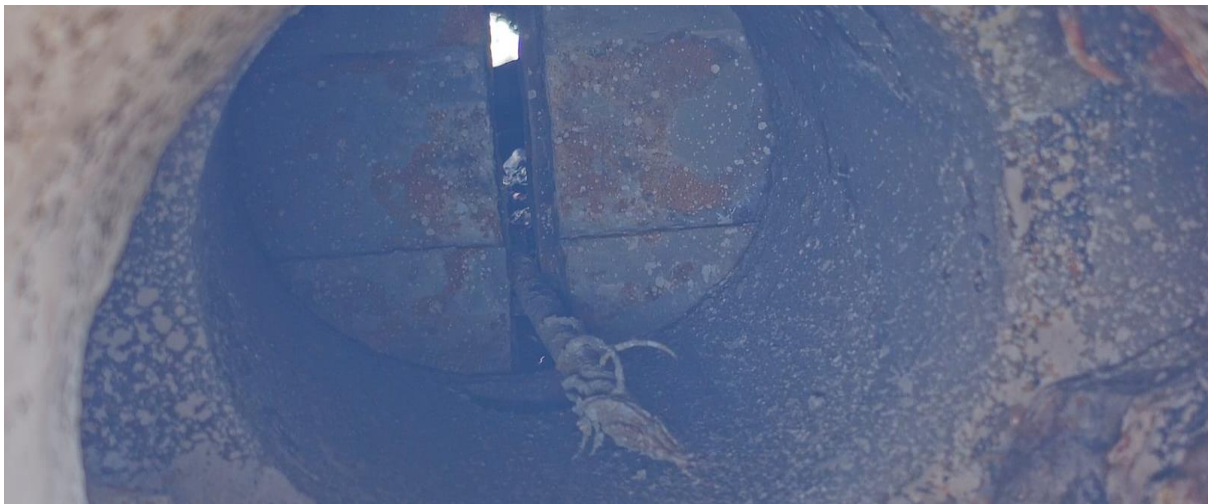
A gas blowout occurred during workover operation being carried out for a zone transfer job. The gas leakage was observed from the well after conventional perforation job. The gas leak ignited after an interval of approximately 50 minutes, leading to a fire at the well site. There were no injuries or casualties reported due to the incident.

- Only five out of twelve studs were found fitted to flange between changeover adapter spool and BOP. After perforation job, leakage was observed at the flange joint between 5M BOP and spool, confirming pressure containment failure at this flange joint.

**Pictures post incident**

- All flange joints must be assembled with full complement of fasteners and gaskets as per requirements of the underlying standards. Pre-job inspection shall verify the integrity of all flanges of well control equipment.
